KONZERVATORSKO-RESTAURATORSKI ZAHVAT NA SJEVERNOM DIJELU ISTOČNE KOLONADE

CONSERVATION-RESTORATION OPERATIONS ON THE NORTHERN PART OF THE EASTERN COLONNADE

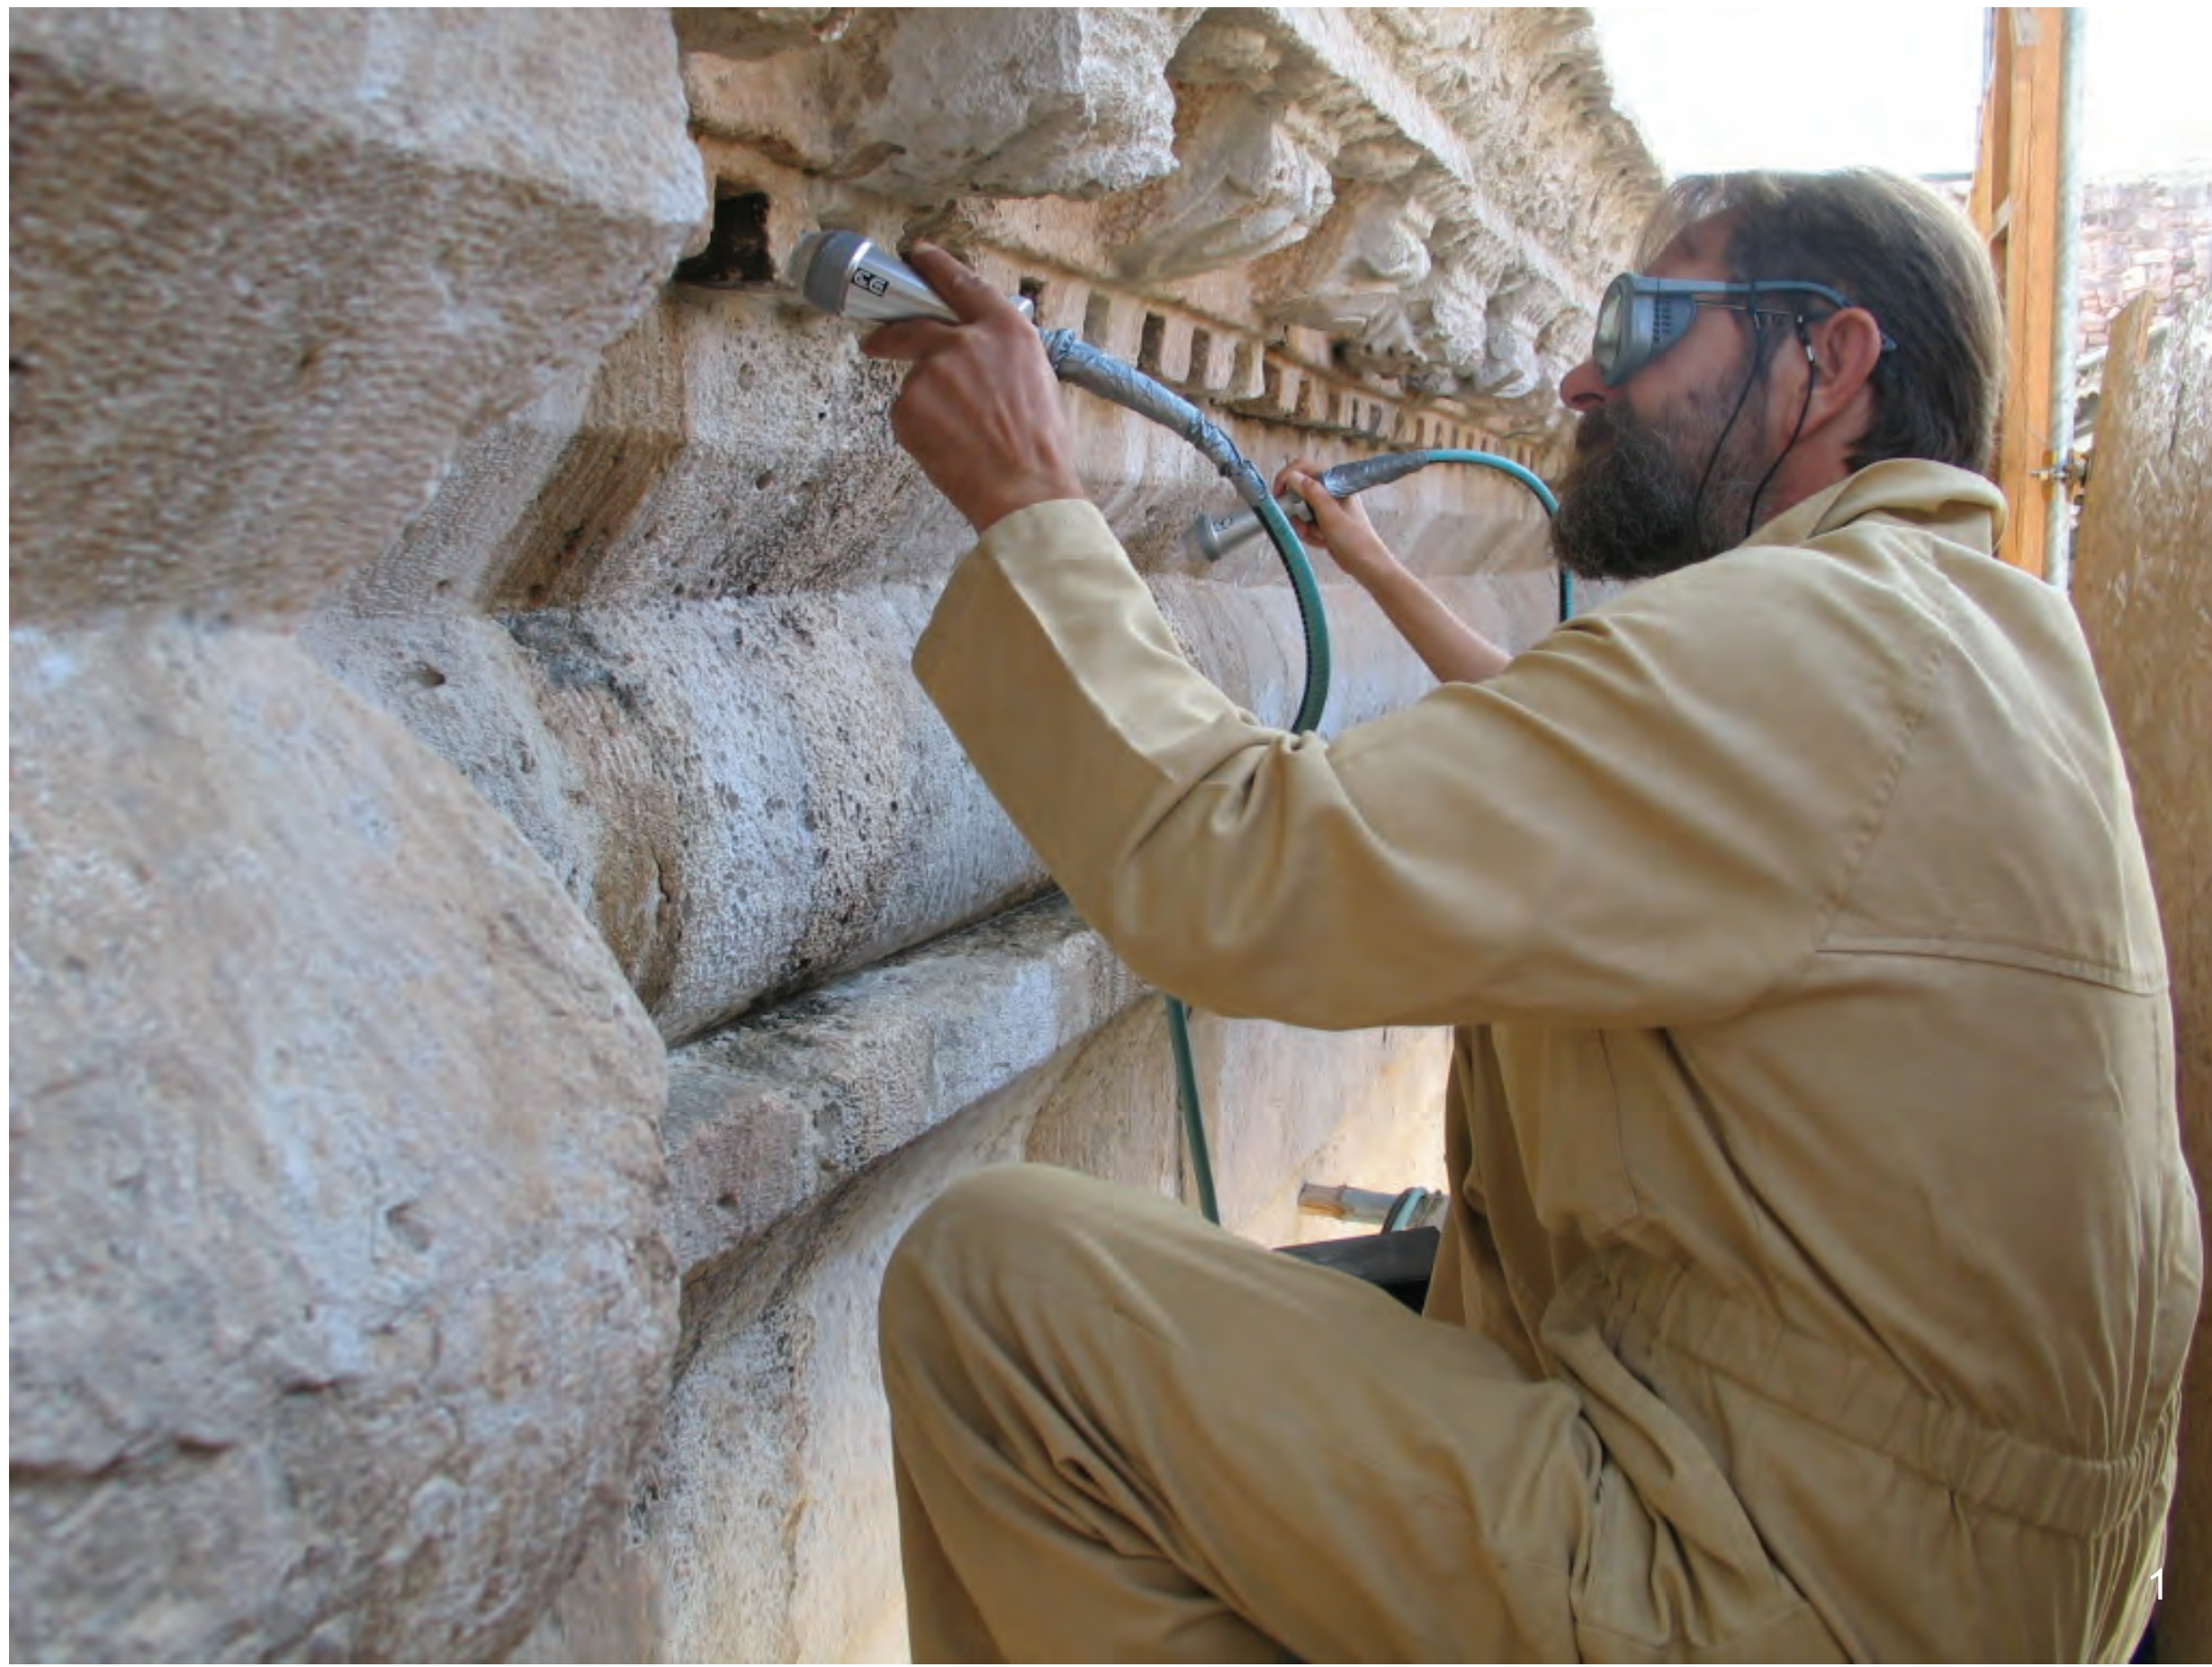
Nakon što je zatečeno stanje dokumentirano arhitektonskim snimkama i fotografski, s površine kamena su odstranjena organska onečišćenja, a iz njegove strukture oblogama izvučene štetne soli. Anorganska onečišćenja – debele crne kore i druge tamne presvlake – odstranjena su metodom laserskog čišćenja. Peristil je jedan od prvih projekata u Hrvatskoj gdje je lasersko čišćenje korišteno kao osnovni postupak čišćenja (SI. 1, SI. 2).

After the as-found condition was documented with architectural drawings and in photographs, the organic dirt was removed from the surface of the stone, and the deleterious salts were removed from the structure with poultices. Inorganic soiling – thick black crust and other dark coatings – was removed with laser cleaning. The Peristyle was one of the first projects in Croatia to use laser cleaning as the basic procedure (Fig. 1, Fig. 2). The iron elements anchored in the stone, and the iron braces or clamps between the

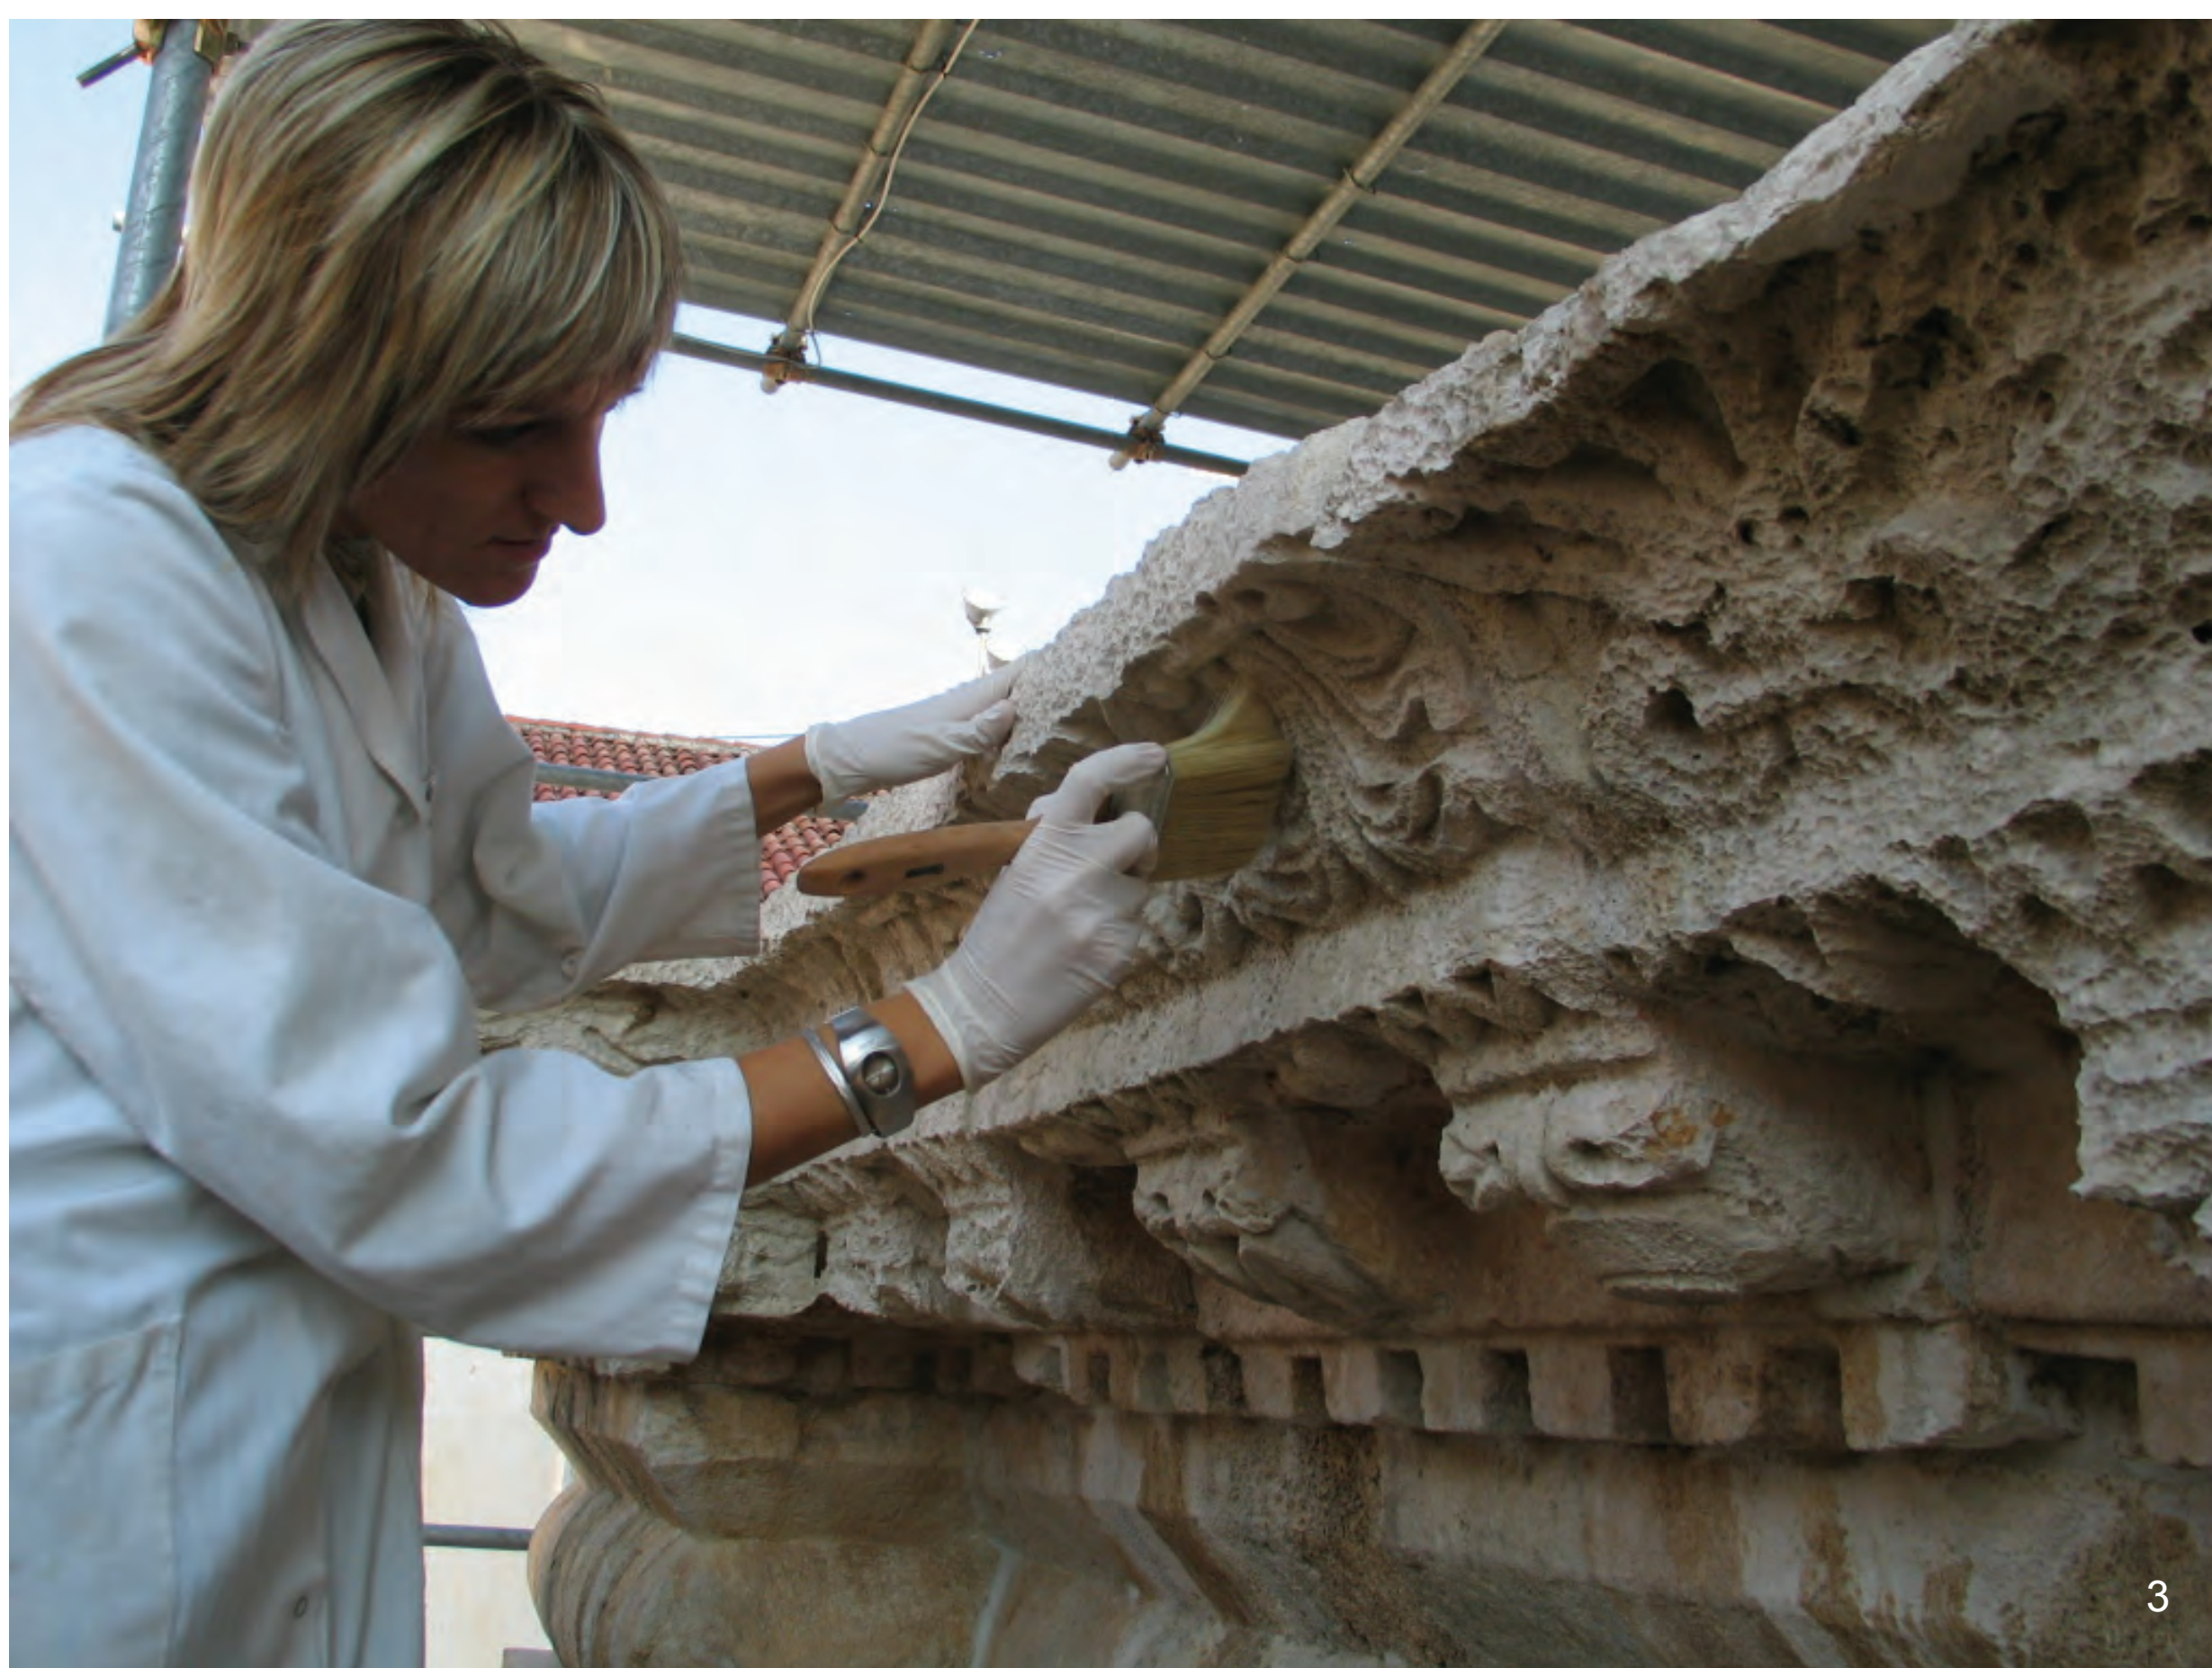
Izvađeni su željezni elementi sidreni u kamen, a željezne spojnice između kamenih blokova na gornjoj plohi kolonade, postavljene u restauraciji s početka 20. stoljeća, nakon vađenja su zamijenjene novima od nehrđajućeg metala tradicionalnom tehnikom zalijevanja u olovo. Odstranjen je cement iz sljubnica između kamenih blokova i zamijenjen akrilno-vapnenom žbukom. Uklonjene su stare cementne zakrpe i zamijenjene novima, od umjetnog kamena. Učvršćeni su nestabilni dijelovi kamenih površina, odnosno mjesta gdje je kamen prijetio ispadanjem ili je napuknuo. Gornje plohe svih istaknutih dijelova – kapitela, profila lukova i drugo – ožbukane su kako bi se osigurao primjereni nagib za pad vode. Iz istog je razloga na gornjoj plohi vijenca izvedena dvostrušna kapa. Na kraju su sve kamene površine tretirane sredstvom za površinsku zaštitu (SI. 3). Radovi su završeni u studenom 2005. godine (SI. 4).

ashlars on the upper surface of the colonnade, installed in a restoration effort of the early 20th century, were removed and replaced with stainless substitutes using the traditional molten lead technique. The cement was removed from the joints between the ashlars and replaced with an acrylic-lime mortar. The old cement patches were removed, and replaced with new patches of artificial stone. The unstable parts of the stone surfaces, that is places in which the stone was cracked or was even likely to come off, were consolidated. The upper surfaces of all projecting parts – of the capitals, the mouldings of the arches and other things – were plastered in order to ensure a proper slope for the drainage of rainwater. For the same reason, a coping was put on the upper surface of the cornice. At the end, all the stone surfaces were treated with a surface-protection preparation (Fig. 3).

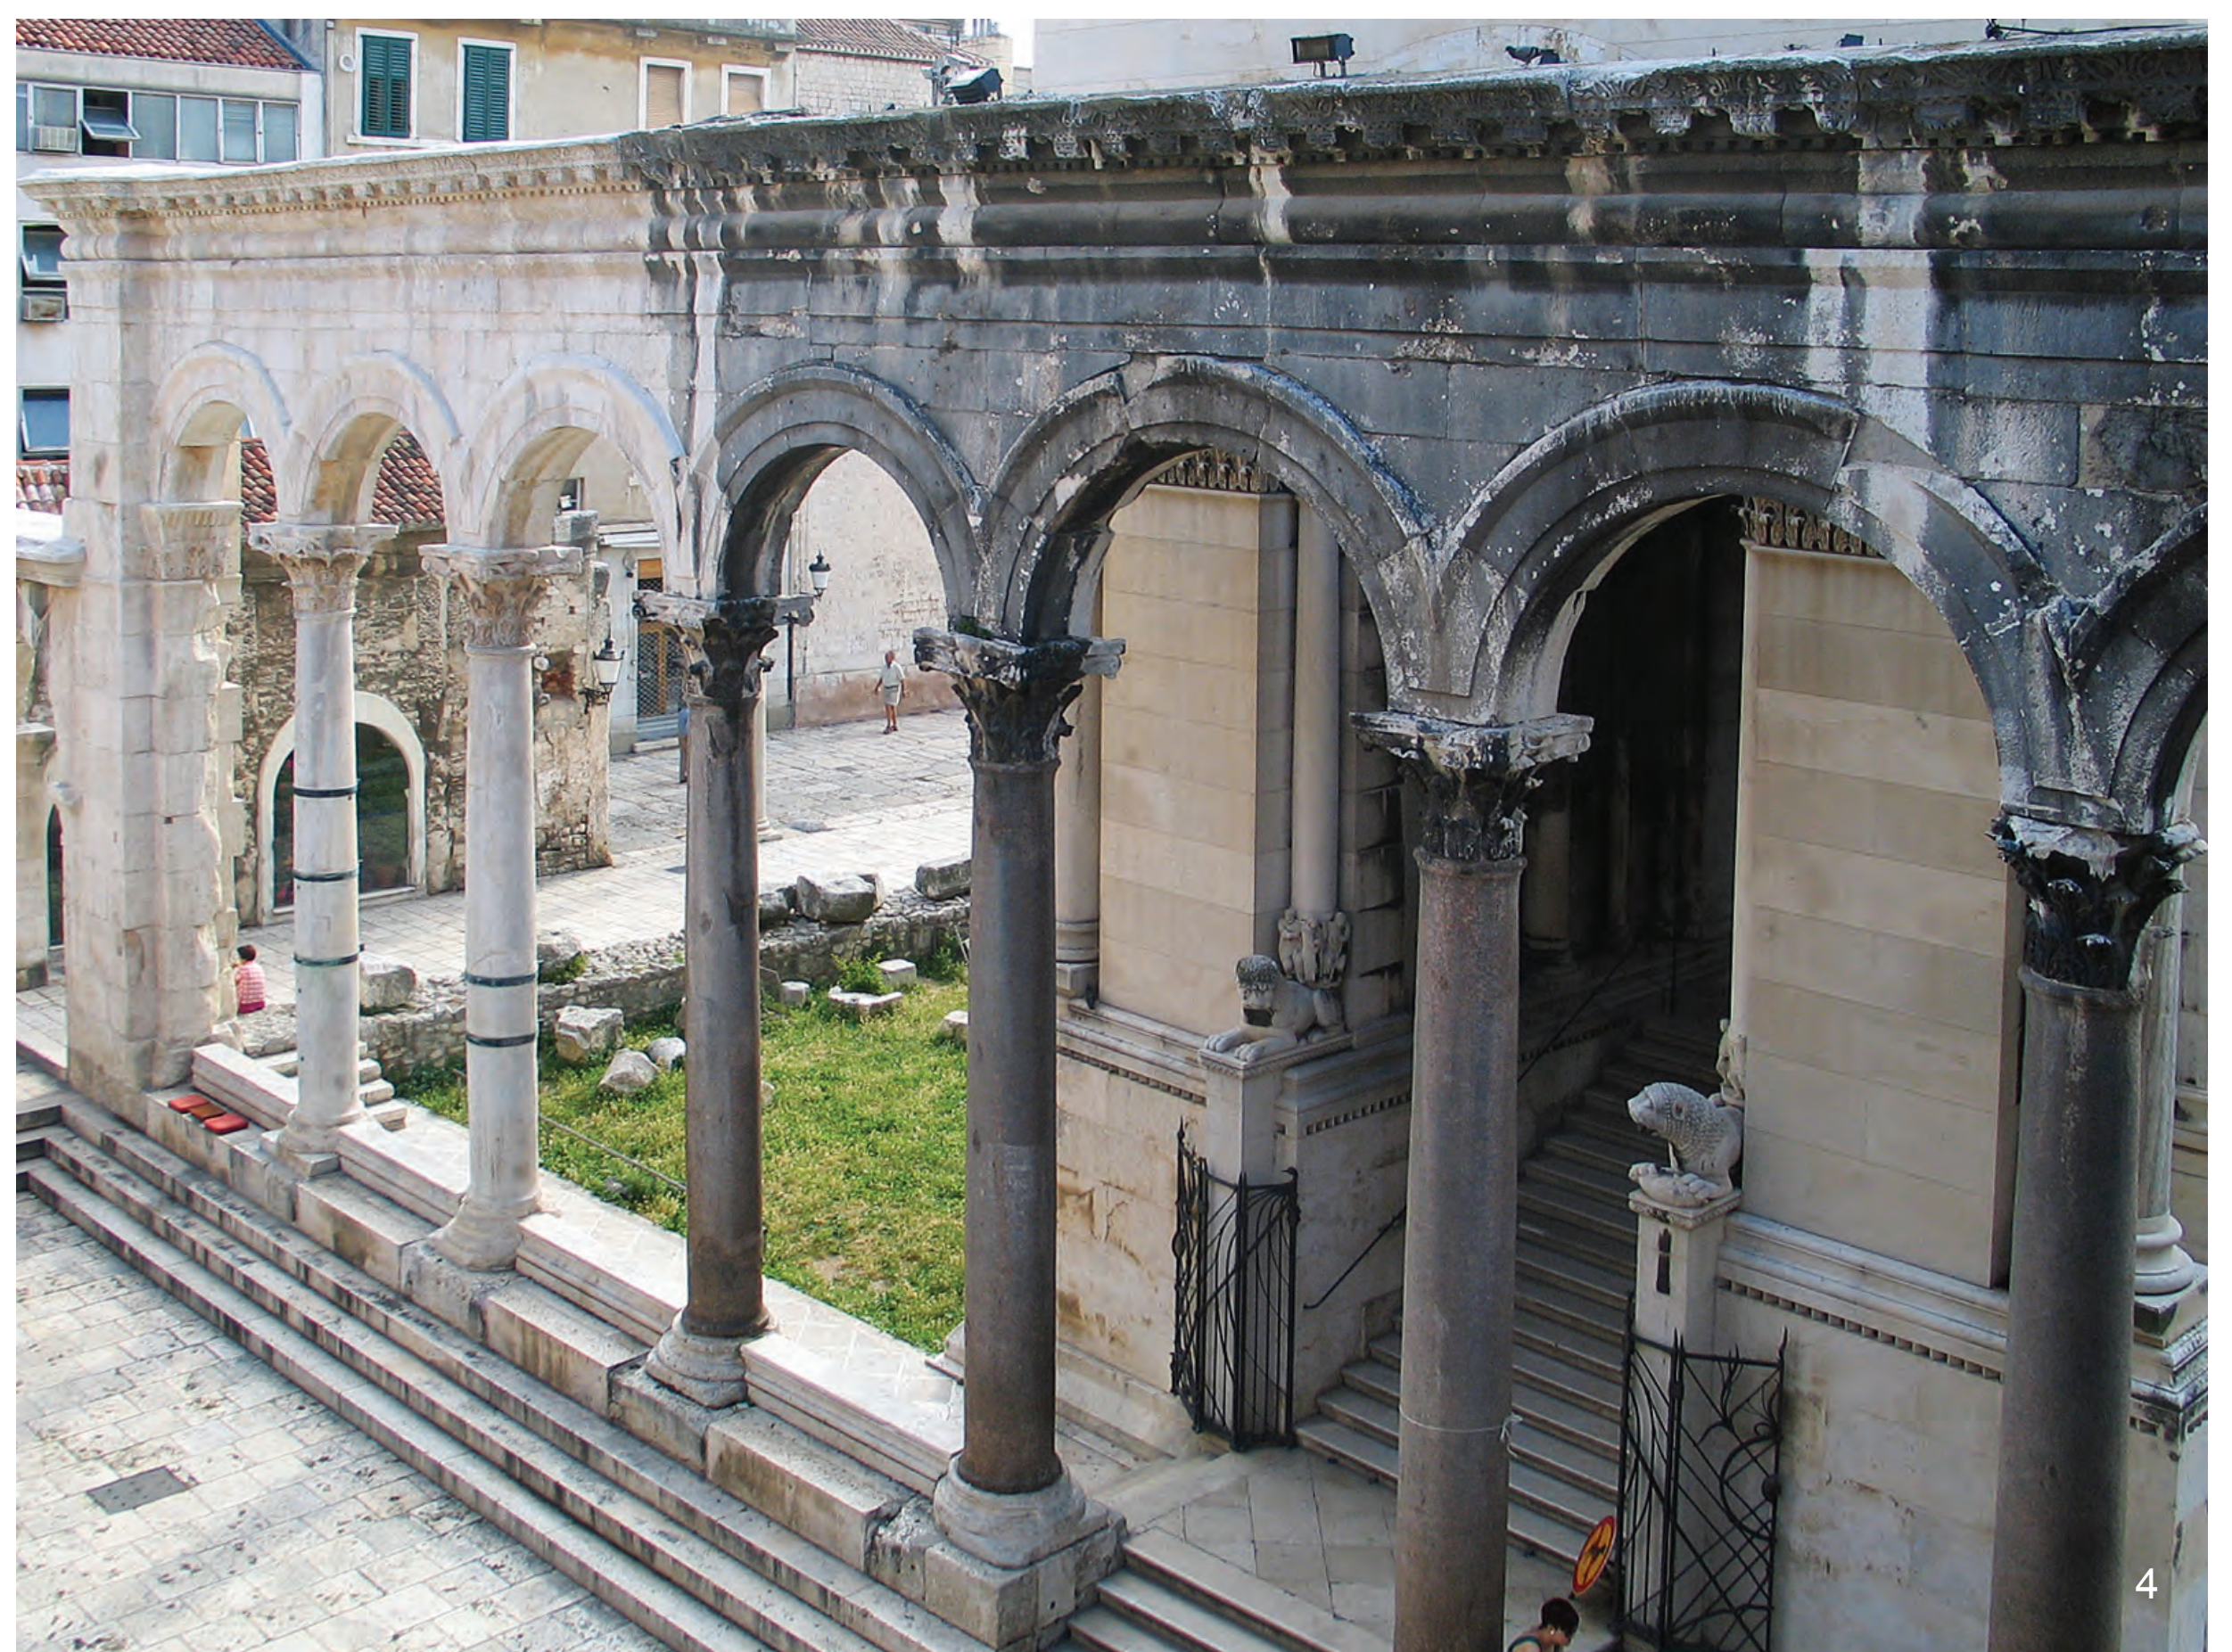
These works were completed in November, 2005 (Fig. 4).
