# KONZERVATORSKO-RESTAURATORSKI ZAHVAT NA JUŽNOM DIJELU ZAPADNE KOLONADE I PROČELJU PALAČE SKOČIBUČIĆ-LUKARIS

## THE CONSERVATION-RESTORATION OPERATION ON THE SOUTHERN PART OF THE WESTERN COLONNADE AND FAÇADE OF THE SKOČIBUČIĆ-LUKARIS PALACE

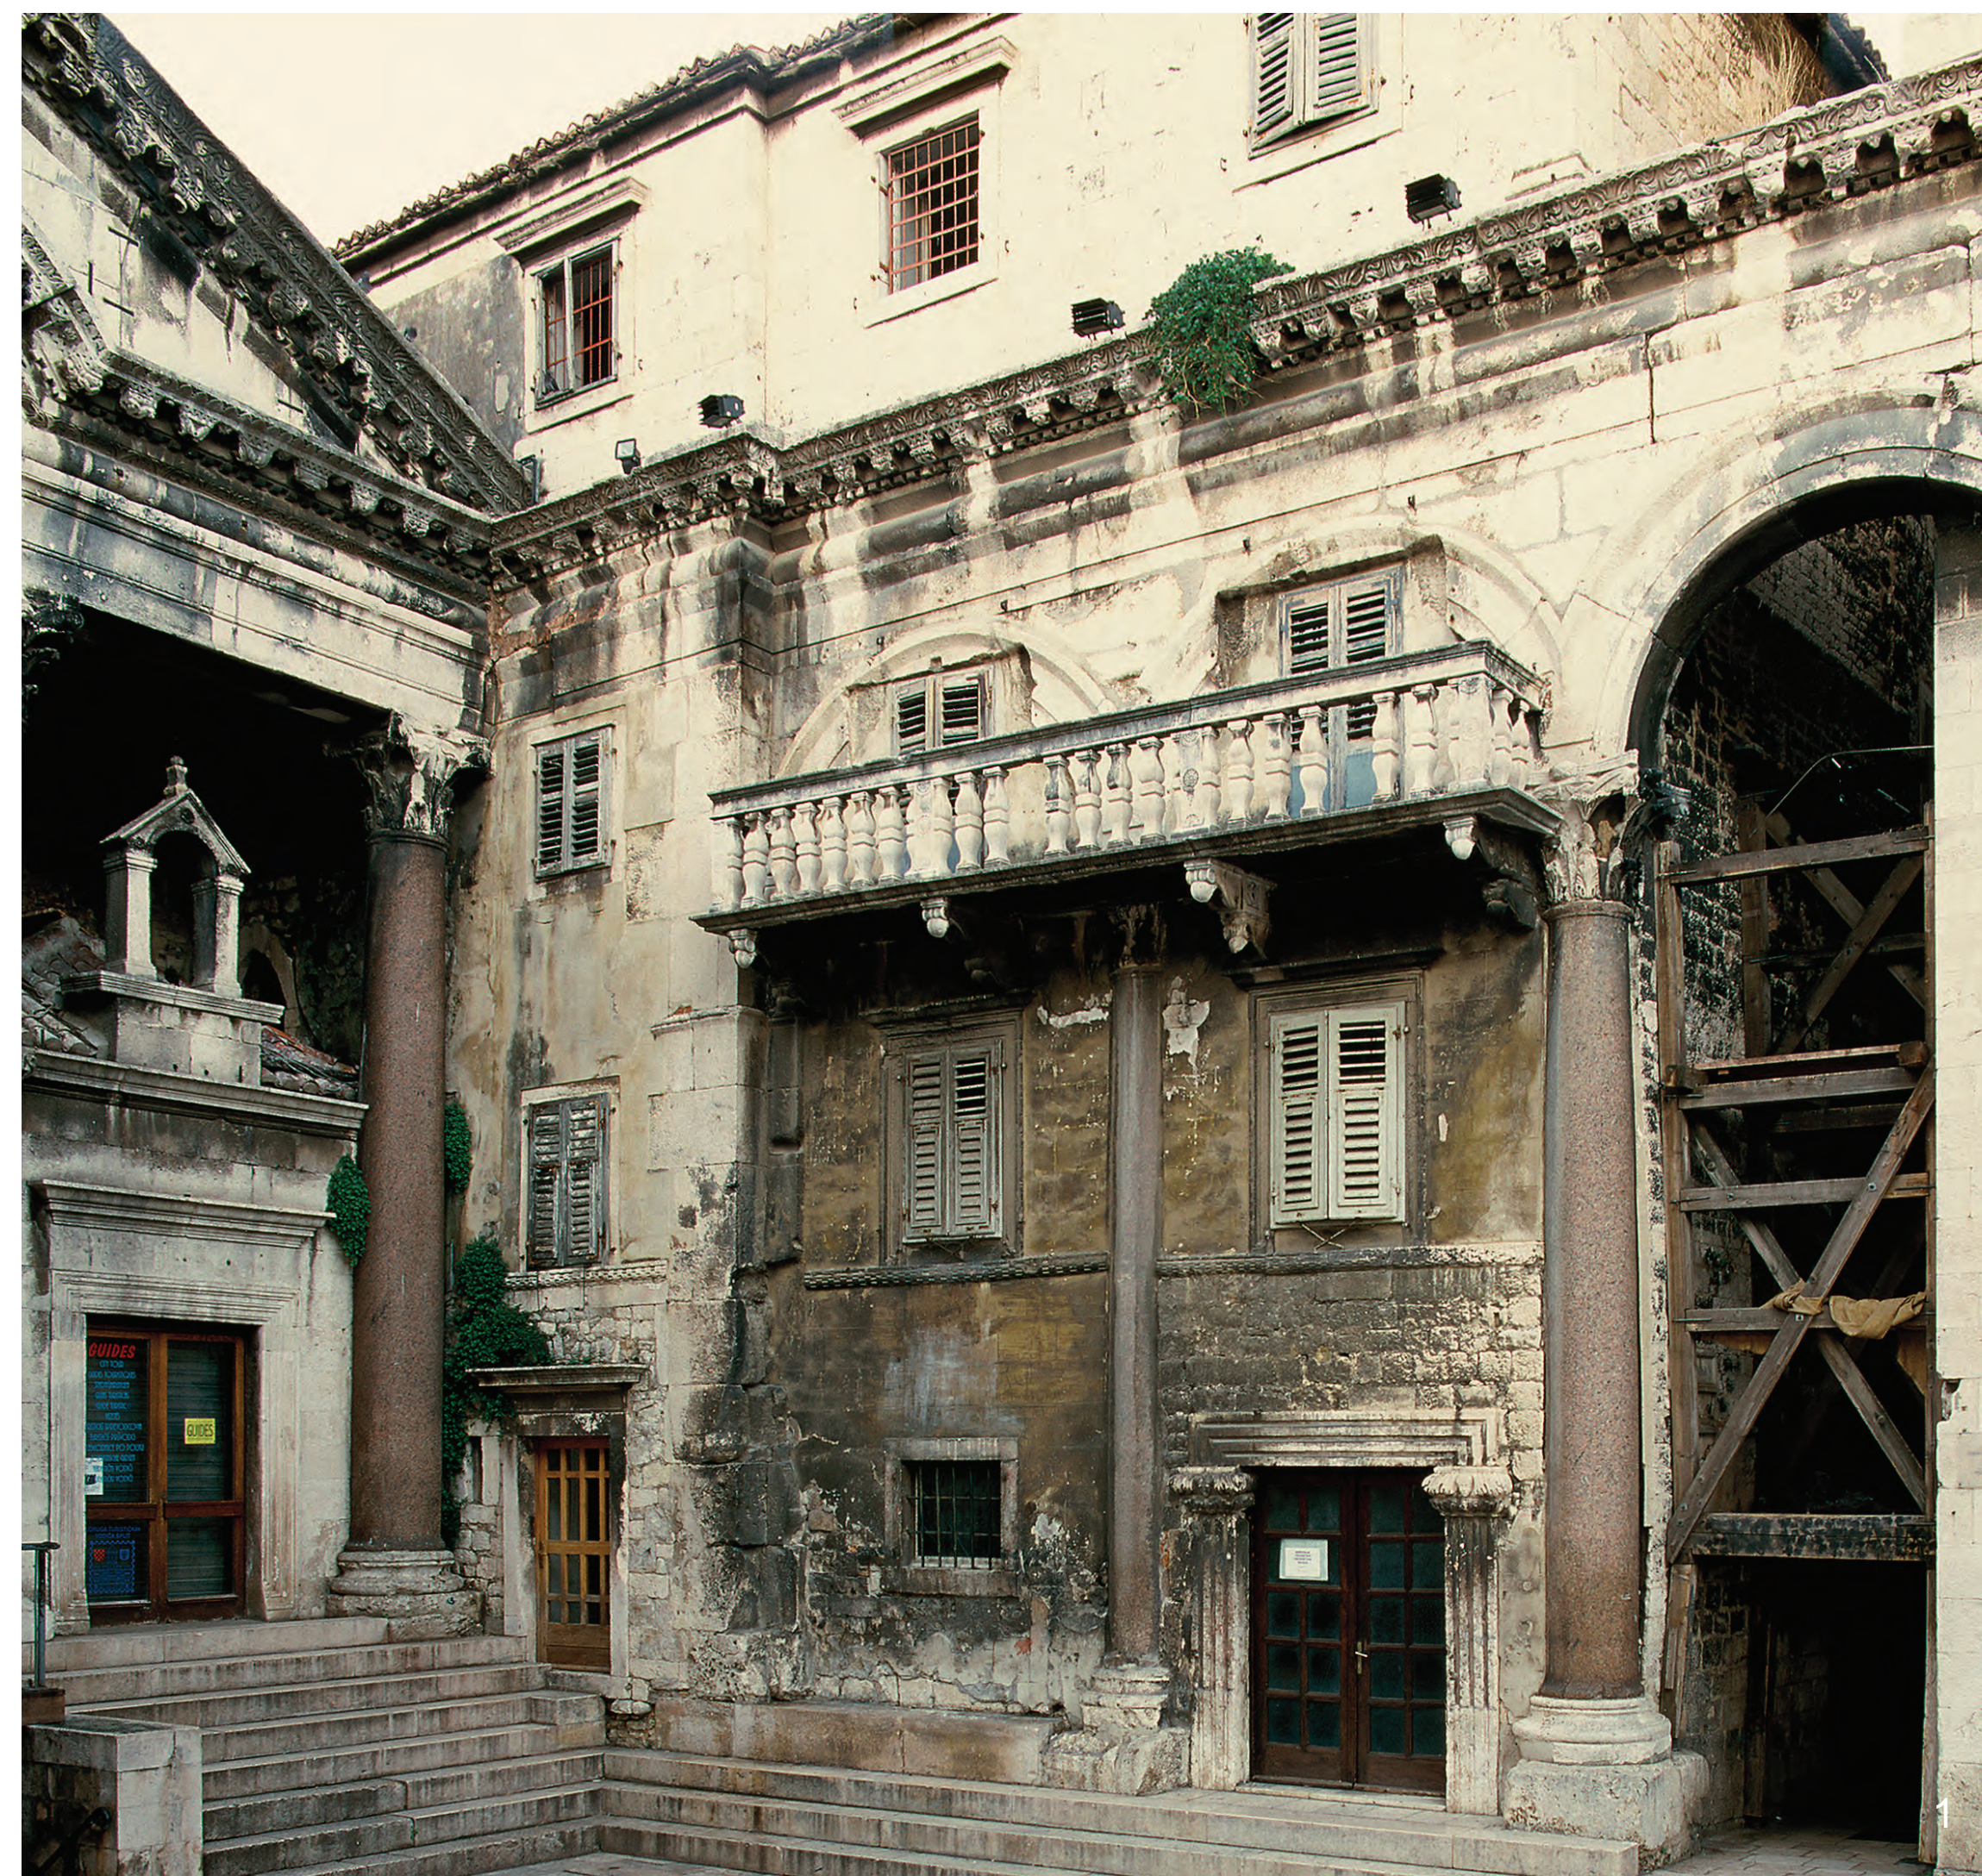
Početak kolovoza 2006. podignuta je radna skela u jugozapadnom uglu trga. Načinjena je arhitektonska snimka južnog dijela zapadne kolonade i pročelja palače Skočibučić-Lukaris (Sl. 1), a dobiveni nacrt je služio kao podloga za precizno ucrtavanje oštećenja i onečišćenja (Sl. 2, Sl. 3). Osim grafički, zatečeno stanje je dokumentirano fotografijama i pisanim izvještajima.

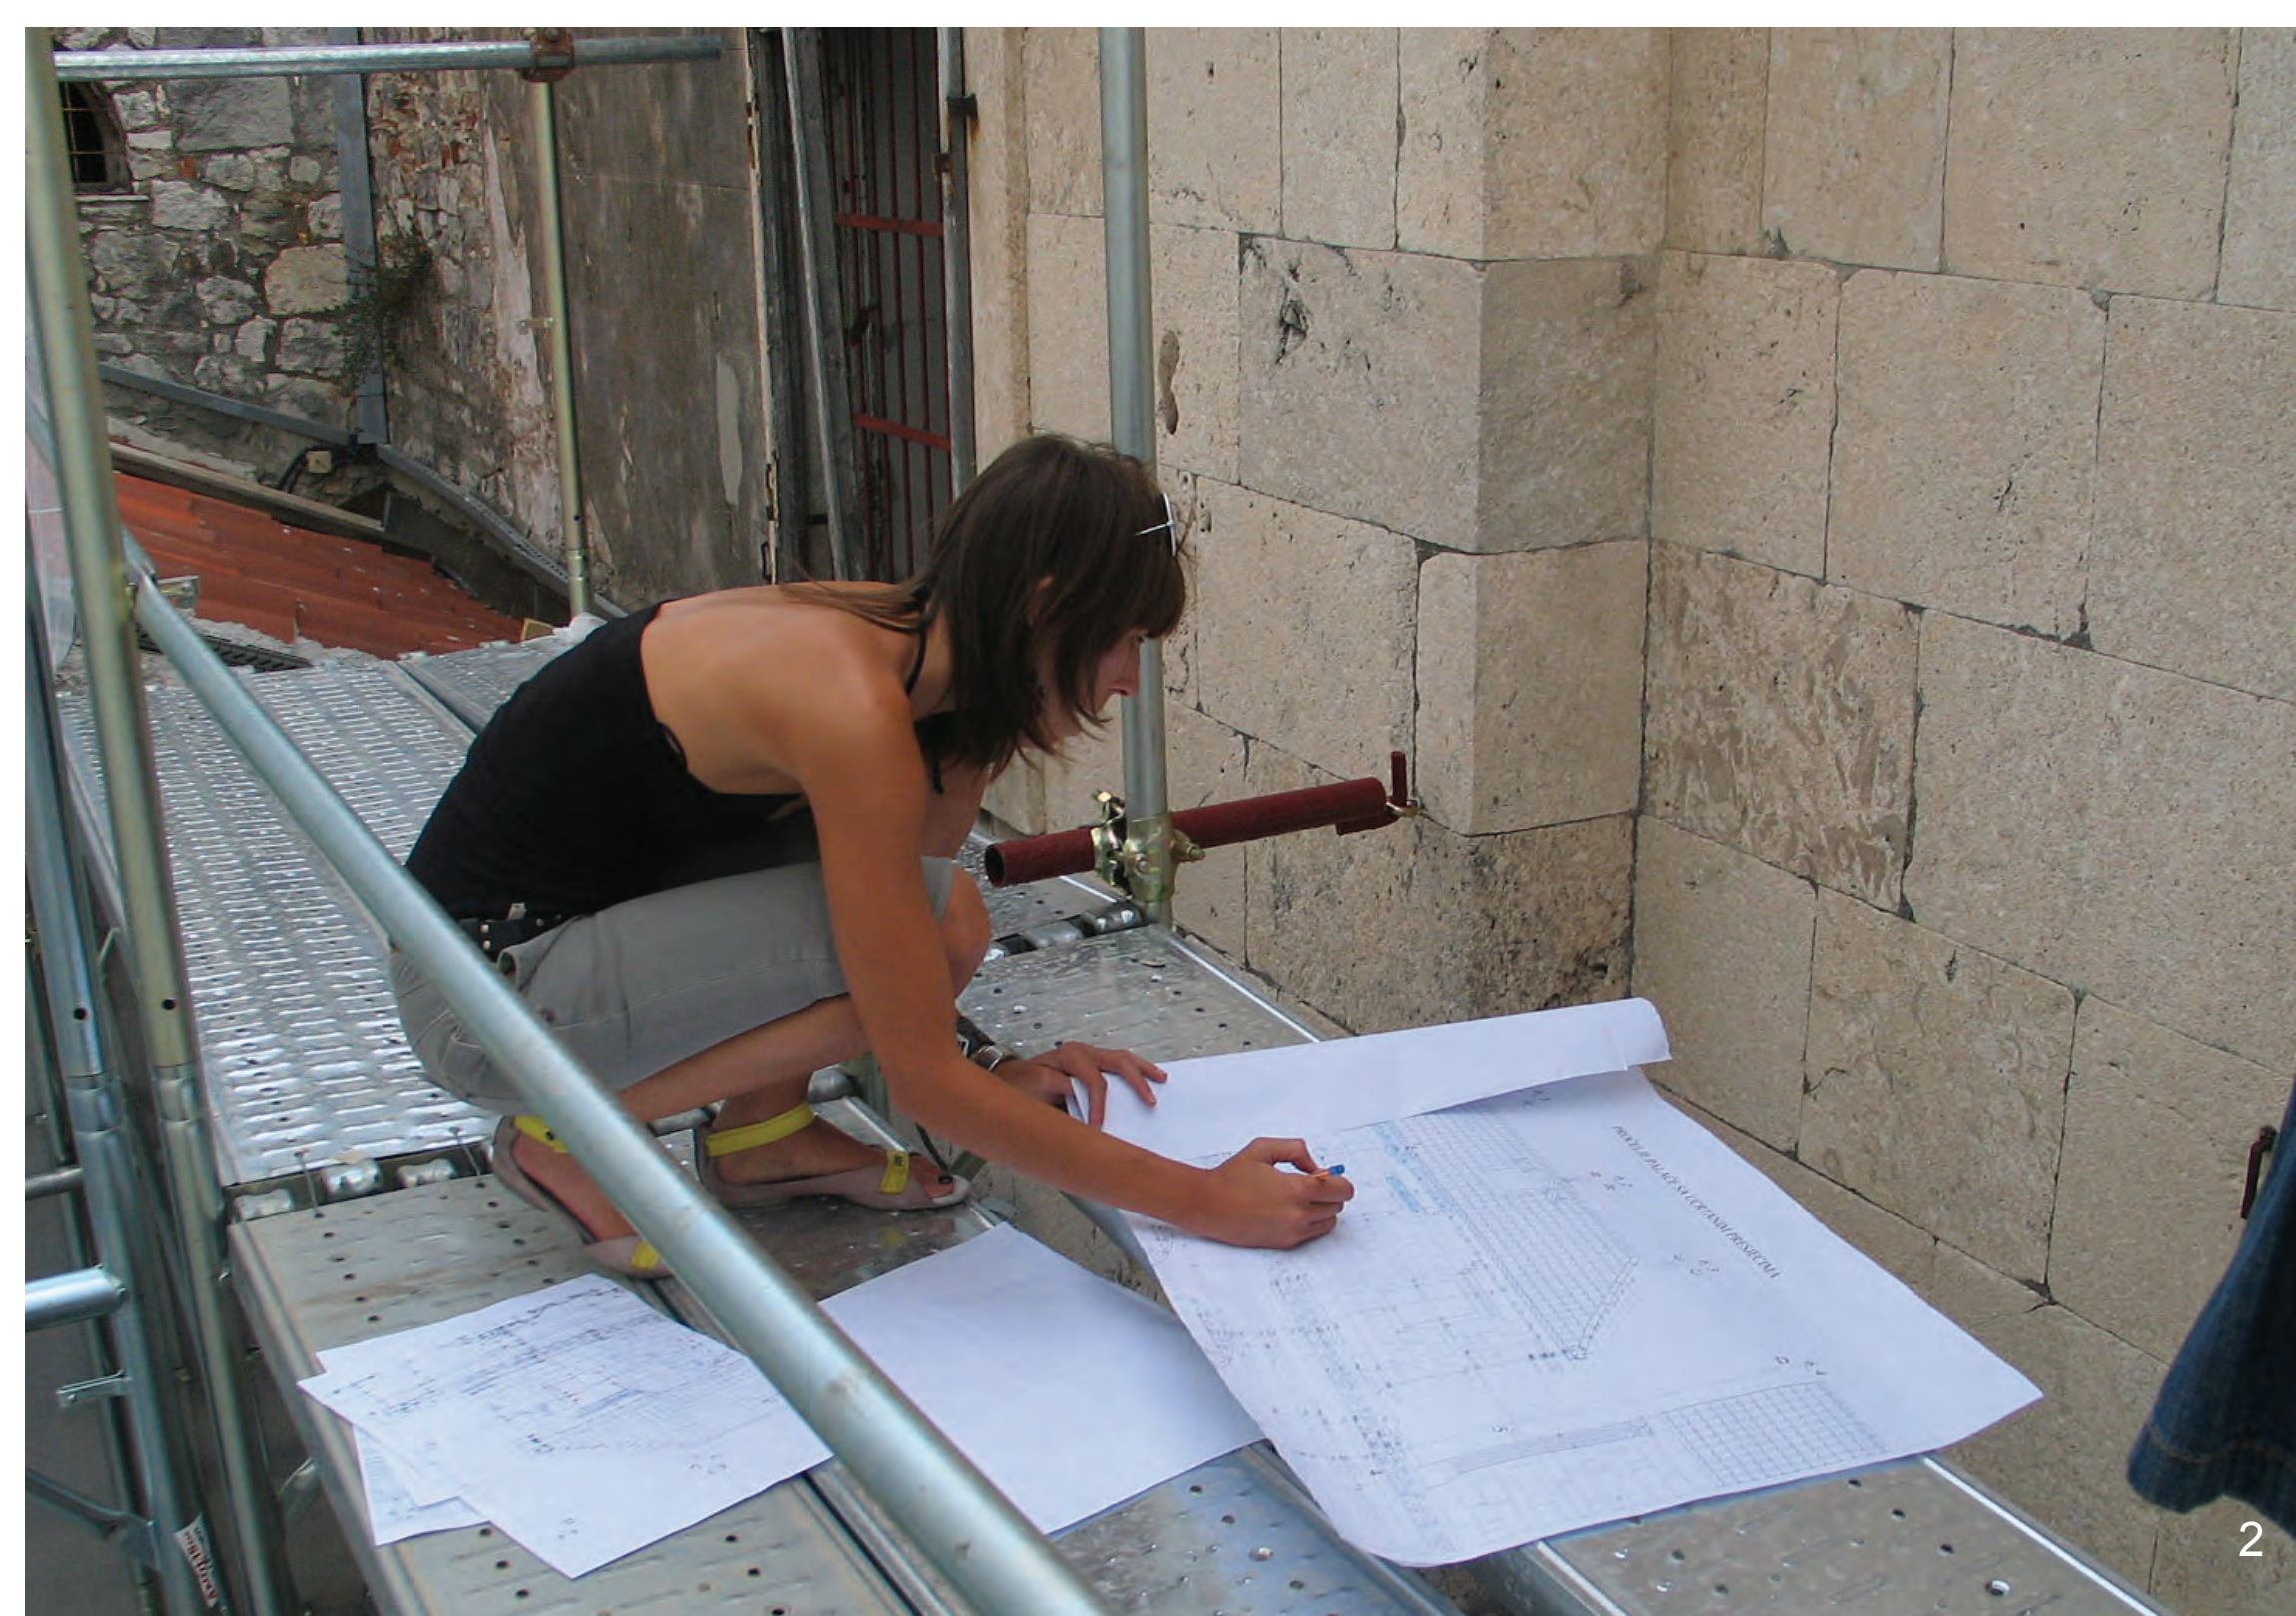
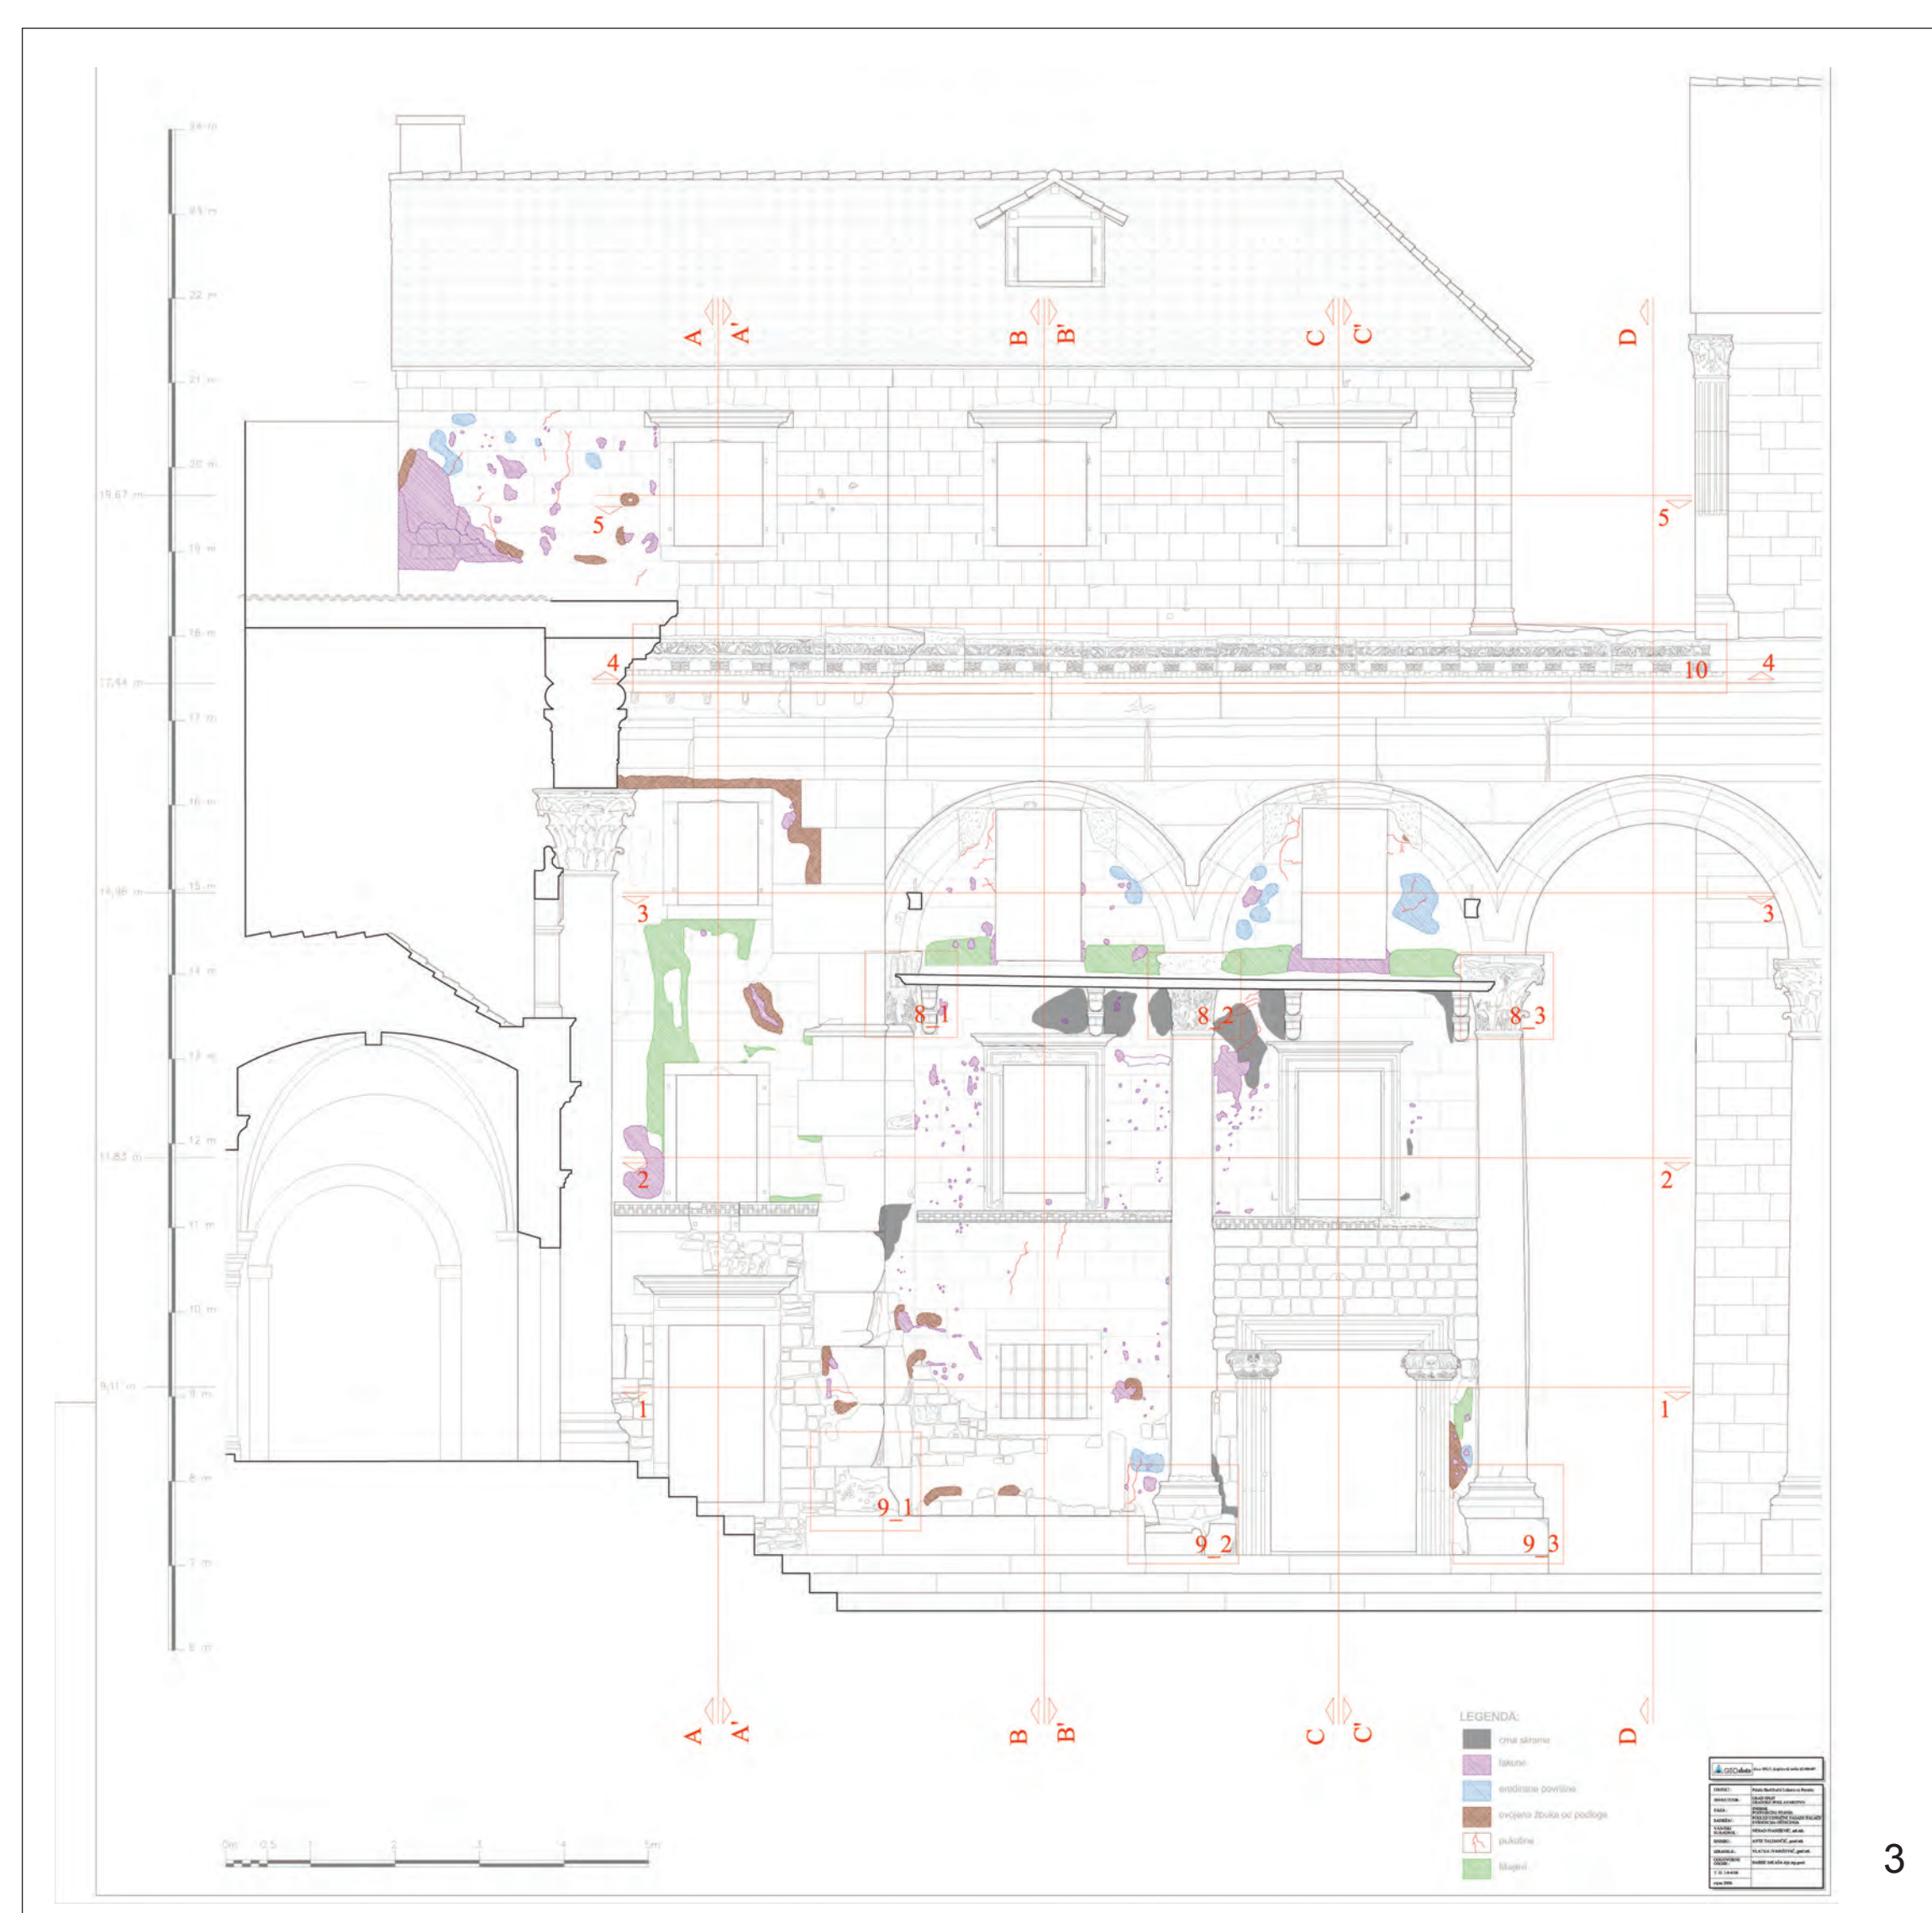
Žbuke su zatečene u jako lošem stanju. Kod dijelova pročelja koji su izloženi kiši površinski sloj žbuke je ispran. Na dijelovima koji su zaklonjeni od kiše na žbukama su se javila anorganska onečišćenja i kalcitne naslage. Žbuka je na ovim dijelovima zasićena štetnim solima, a bojom se razlikuje od žbuke na ostalim dijelovima zgrade.
