HRVATSKI  
RESTAURATORSKI  
ZAVOD

# PREGLJED TRENUTNOG STANJA DRVENIH POLIKROMIRANIH SKULPTURA IZ GORE

## OVERVIEW OF THE CURRENT STATE OF WOODEN POLYCHROMED SCULPTURES FROM GORA

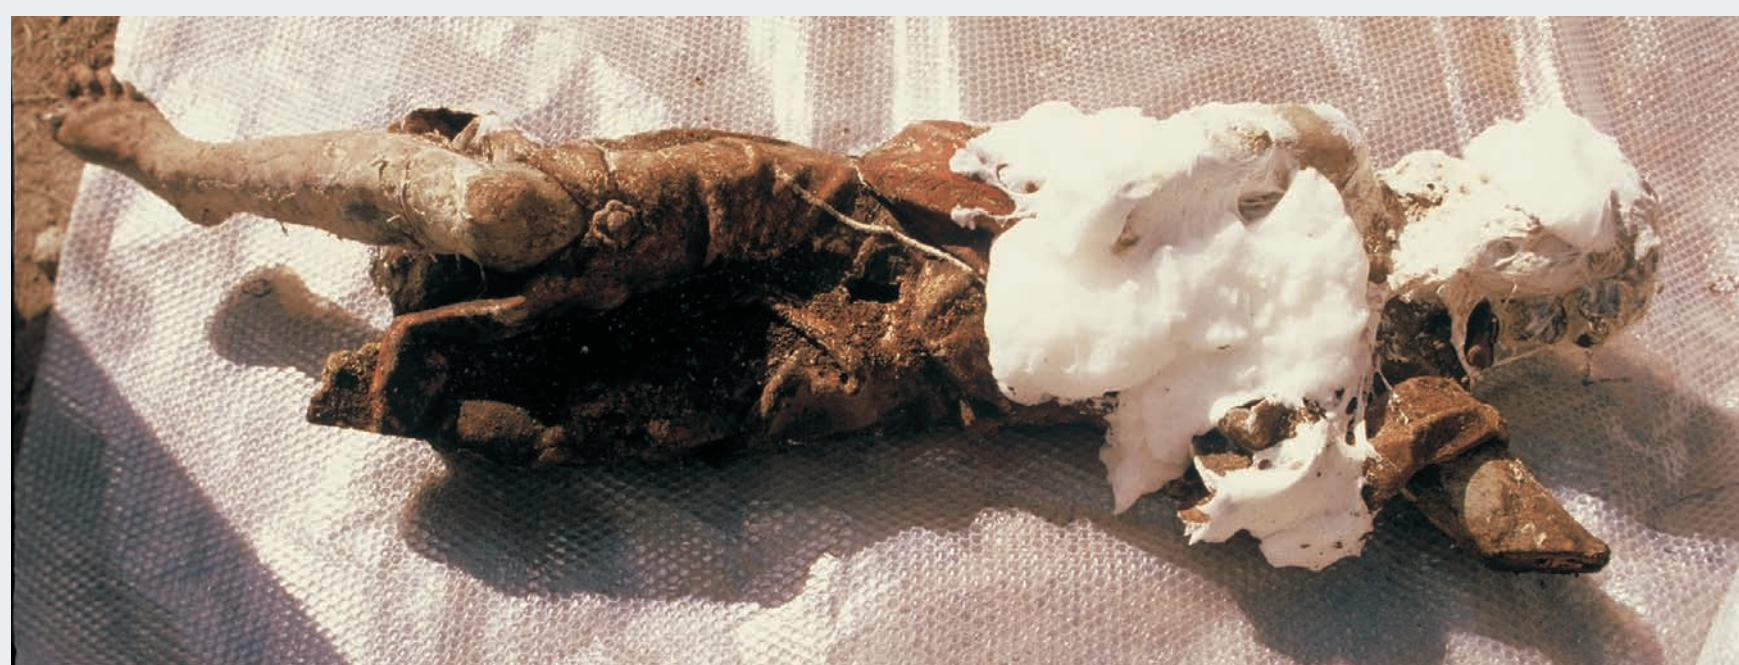
**2** Skulpture su se nalazile u polu raspadnutom stanju na vlažnom, rahlo mekanom humusu prekrivene obiljem plijesni, gljivica, biološkog otpada, izmeta i uginulih životinja (ptica). Iako je 1997. godine bila izrazito suha jesen, vlaga u kripti bila je previsoka. Bile su pomiješane s lješovima (cjelovitim i raspadnutim) te ljudskim kostima. Bile su trule, raskvašene, mekane na dodir i izuzetno krhke.

Sl.2. Zatečeno stanje Anđela - total, fotografija prikazuje infestaciju skulpture bijelom plijesni i gljivicama (dokumentacija HRZ-a)  
Pic.2. Prior condition of the Angel - total, the photograph shows infestation of the sculpture using white mould and fungi (documentation of the Croatian Conservation Institute)

**3** Zbog trenutne situacije i lošeg stanja skulptura trebalo je brzo reagirati i spriječiti daljnje djelovanje mikroorganizama na skulpture te prenatrag sušenje. Stoga su umotane u polietilenske folije i prevezene u Zagreb, gdje su neraspakirane smještene u Zavod za restauriranje umjetnina (danas HRZ) u prihvatnu čuvarnicu zvanu "dezinfekcija". U ponedjeljak, 6. listopada 1997. u Institutu "Ruđer Bošković" izvršeno je zračenje gama zrakama u dozi dovoljnoj za dezinficiranje skulptura. Nakon zračenja skulpture su vraćene u prihvatnu čuvarnicu Zavoda gdje je adaptirana komora za njihovo postupno sušenje. U tijeku sušenja došlo je do ponovne aktivacije plijesni i gljivica te je ponovljeno dezinficiranje gama zračenjem 1. travnja 1998. g. Skulpture su unutar prihvatne čuvarnice premještene na police s RV zraka unutar raspona 45-65%. Takva vlažnost ne omogućuje aktivnost gljivica budući da se i vlažnost drva ekvilibrirala na te "normalne" uvjete. U idealnim uvjetima bilo bi poželjno analizu plijesni i gljivica napraviti prije tretmana dezinfekcije i tim putem pronaći adekvatnu metodu dezinficiranja. Međutim, tadašnja specifična situacija zahtijevala je brzo reagiranje. Zbog toga su naknadno uzeti uzorci za analizu plijesni i gljivica sa skulptura. Analize su pokazale prisutnost više vrsta plijesni (Alternaria tenuis 1211, Sordaria fimicola 1051, Paecilomyces variotii 1001 i Penicillium chrysogenum 615) i bakterija (Bacillus sp. Streptomyces sp.). Pronađeni mikroorganizmi štetni su za ljudsko zdravlje. Nastavak radova započeo je 2004. i trajao do 2006. godine konsolidacijom drvenog nosioca, podljepljivanjem bojanog sloja te uklanjanjem površinske nečistoće mehaničkim i kemijskim putem. Zbog preopterećenosti Zavoda ugovorenim poslovima, na skulpturama nisu izvođeni daljnji konzervatorsko-restauratorski radovi te su skulpture 2007. godine pohranjene u centralnu čuvarnicu Restauratorskog centra u Ludbregu, gdje se održavaju i idealni mikroklimatski uvjeti.

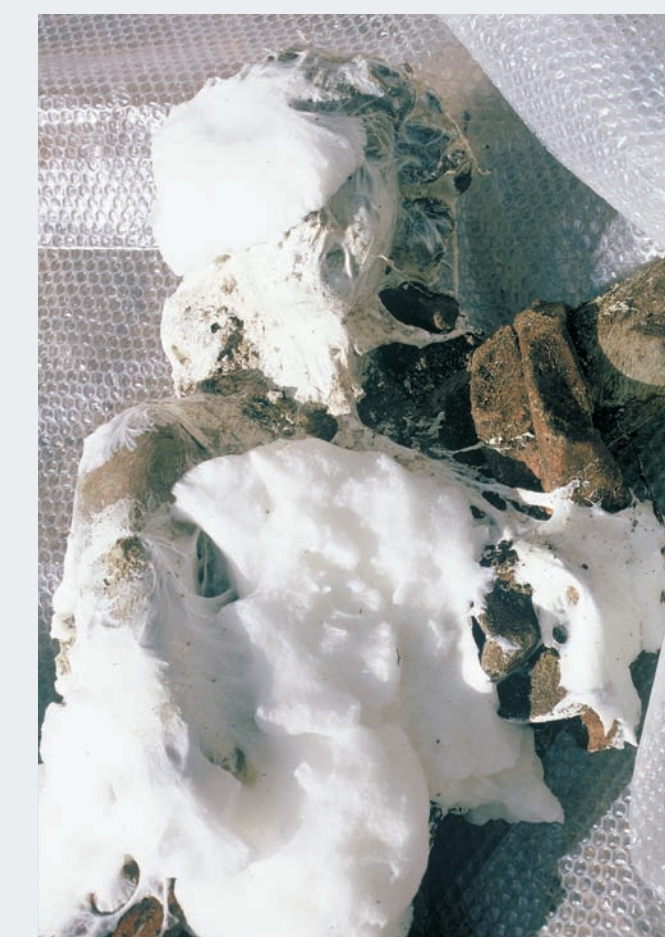
Sl.3. Zatečeno stanje Anđela - detalj, fotografija prikazuje infestaciju skulpture bijelom plijesni i gljivicama (dokumentacija HRZ-a)  
Pic.3. Prior condition of the Angel - detail; the photograph shows infestation of the sculpture using white mould and fungi (documentation of the Croatian Conservation Institute)

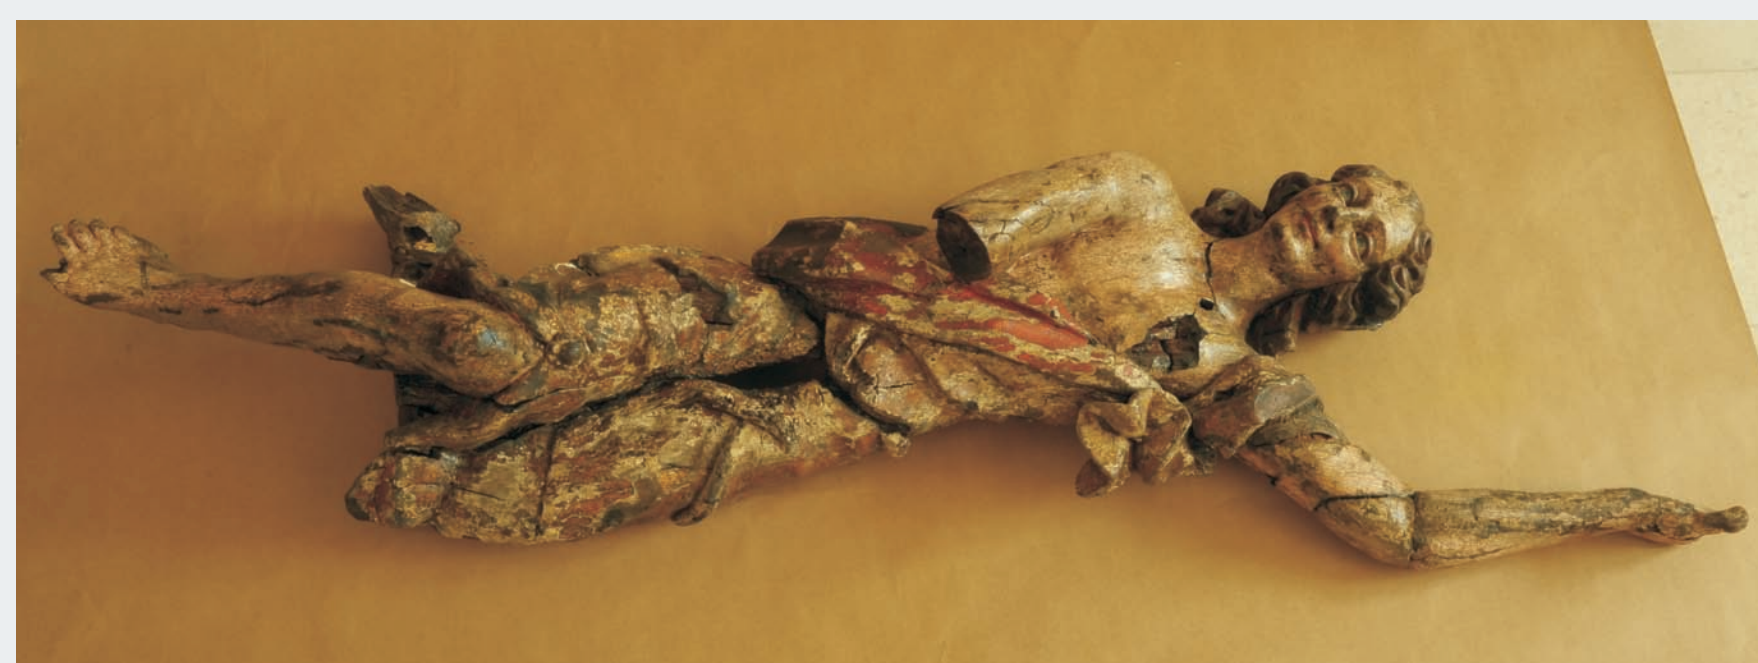
Sl.6. Zatečeno stanje Anđela - total 2011., fotografija prikazuje današnje stanje nakon izvođenja konzervatorsko-restauratorskih radova završenih 2006. godine (dokumentacija HRZ-a, snimio M. Braun)  
Pic.6. Prior condition of the Angel - total in 2011., the photograph shows present condition after conservation-restoration processes had finished in 2006 (documentation of the Croatian Conservation Institute; photo by M. Braun)

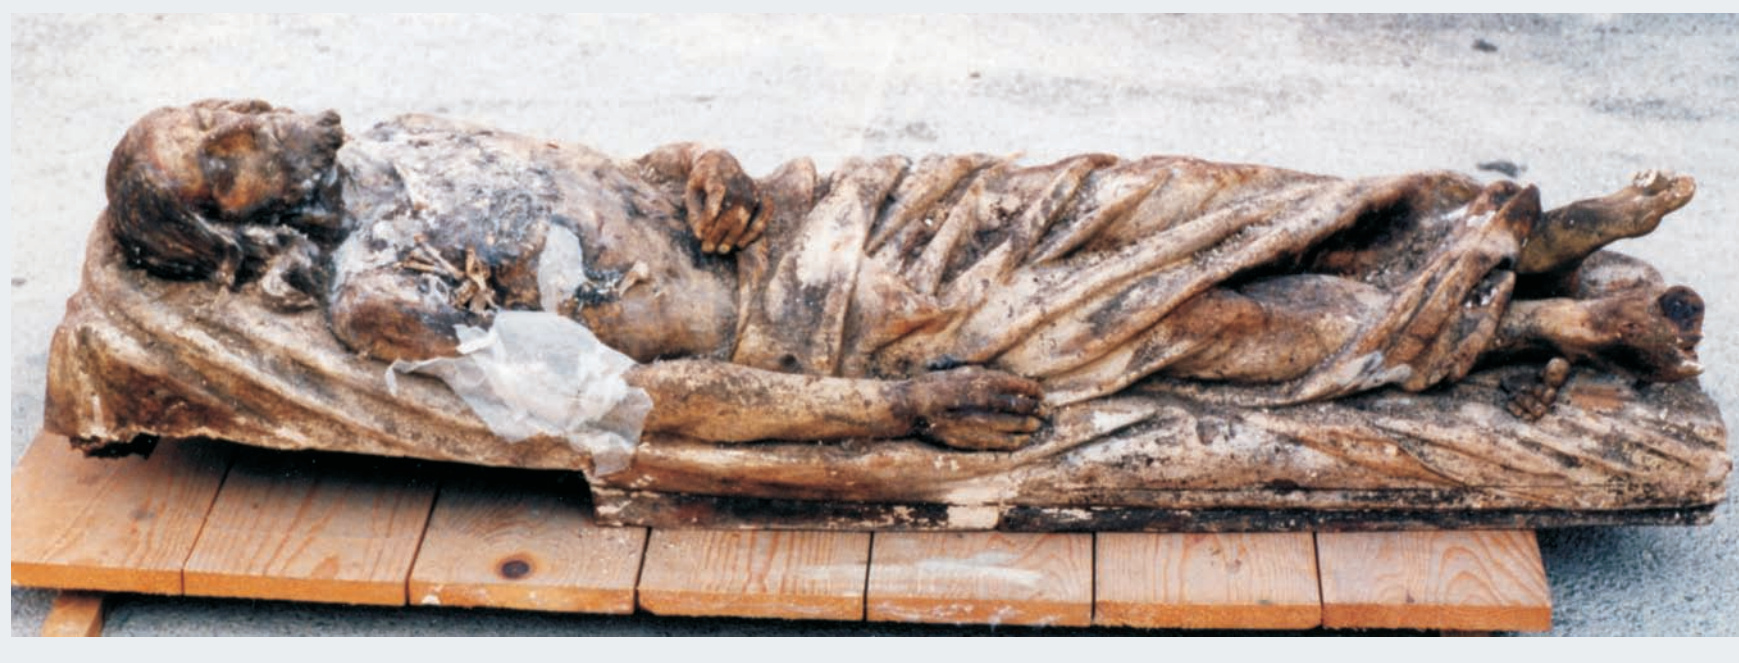
Sl.4. Zatečeno stanje Mrtvog Krista - total, fotografija prikazuje infestaciju skulpture plijesni i gljivicama, biološkim otpadom i humusom (dokumentacija HRZ-a)  
Pic.4. Prior condition of the Dead Christ - total; the photograph shows infestation of the sculpture with white mould, biological waste and humus (documentation of the Croatian Conservation Institute)

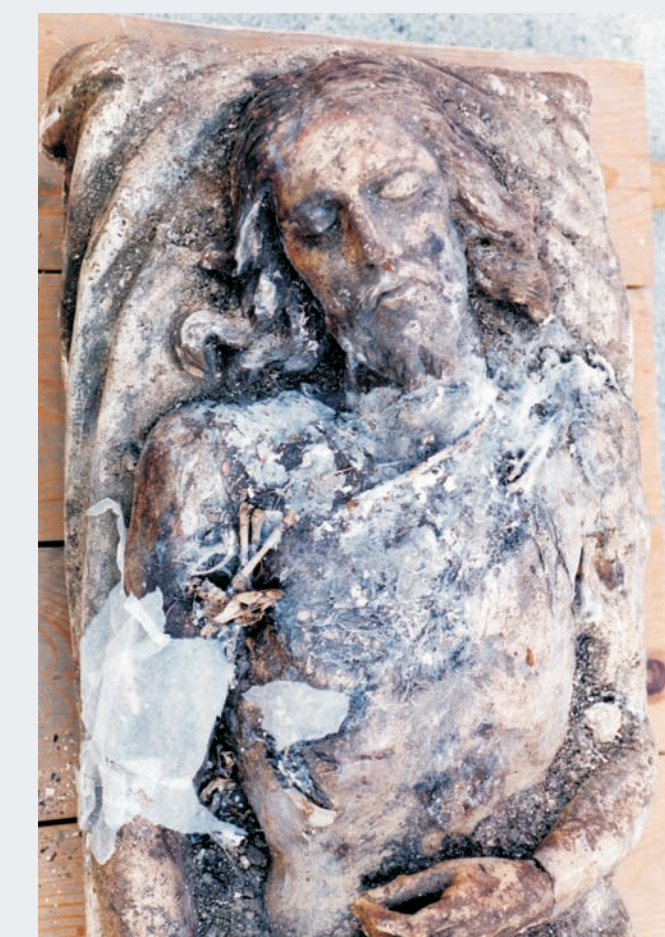
Sl.5. Zatečeno stanje Mrtvog Krista - detalj, fotografija prikazuje infestaciju skulpture plijesni i gljivicama, biološkim otpadom i humusom (dokumentacija HRZ-a)  
Pic.5. Prior condition of the Dead Christ - detail; the photograph shows infestation of the sculpture with white mould, biological waste and humus (documentation of the Croatian Conservation Institute)

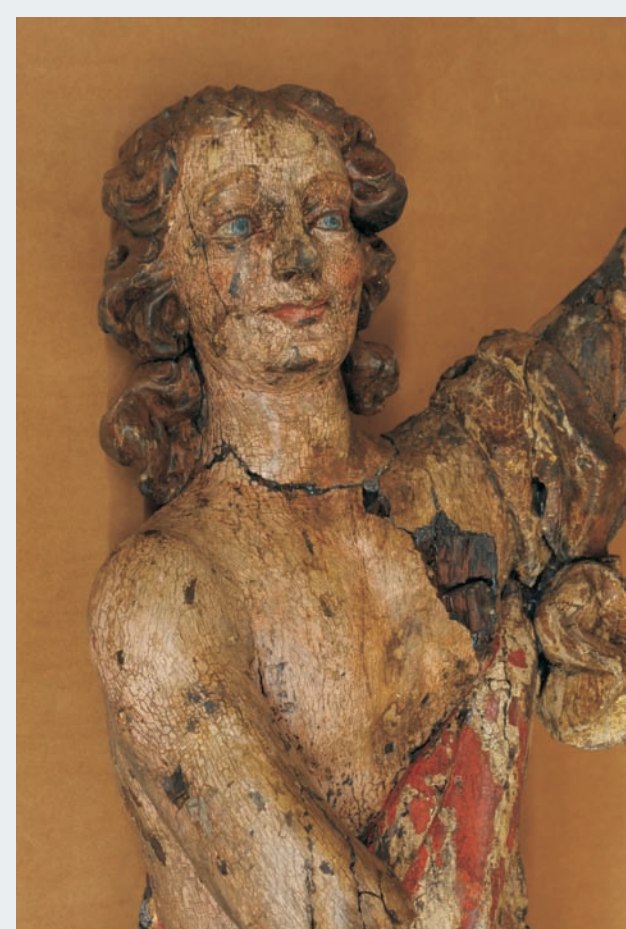
Sl.7. Zatečeno stanje Anđela - detalj torzo 2011., fotografija prikazuje današnje stanje nakon izvođenja konzervatorsko-restauratorskih radova završenih 2006. godine (dokumentacija HRZ-a, snimio M. Braun)  
Pic.7. Prior condition of the Angel torso detail in 2011., the photograph shows present condition after conservation-restoration works finished in 2006. (documentation of the Croatian Conservation Institute; photo by M. Braun)

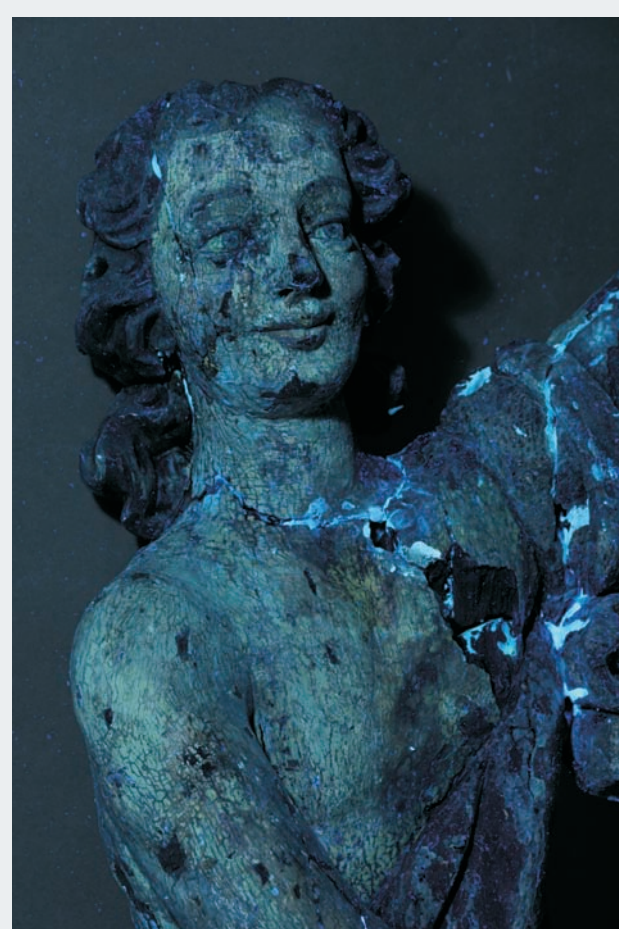
Sl.8. Zatečeno stanje Anđela - detalj torza 2011., na UV-fotografiji primjećuju se ostaci konsolidanta i nisu primijećeni mikroorganizmi (dokumentacija HRZ-a, snimio M. Braun)  
Pic.8. Prior condition of the Angel - torso detail in 2011.; UV photography shows consolidant's debris and there's no sign of microorganisms (documentation of the Croatian Conservation Institute; photo by M. Braun)

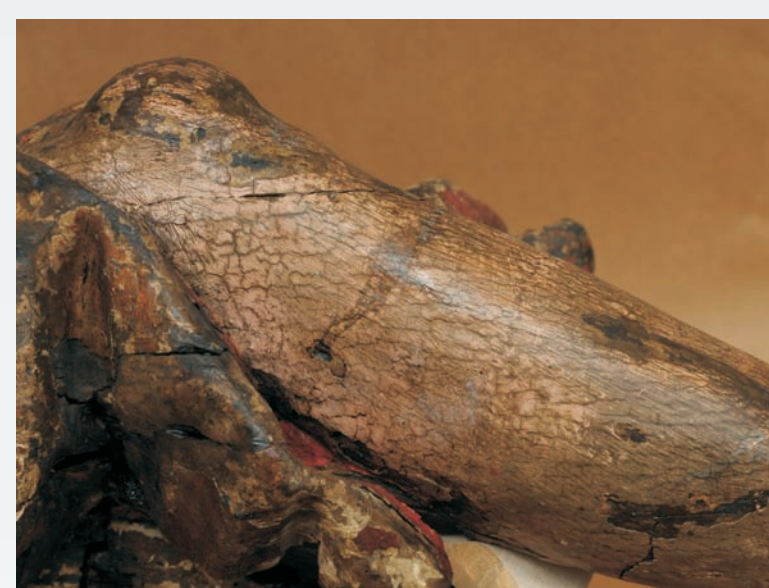
Sl.9. Zatečeno stanje Anđela - detalj desne noge 2011., fotografija prikazuje današnje stanje nakon izvođenja konzervatorsko-restauratorskih radova završenih 2006. godine (dokumentacija HRZ-a, snimio M. Braun)  
Pic.9. Prior condition of the Angel - right leg detail in 2011; the photograph shows present condition after conservation-restoration works finished in 2006. (Documentation of the Croatian Conservation Institute; photo by M. Braun)

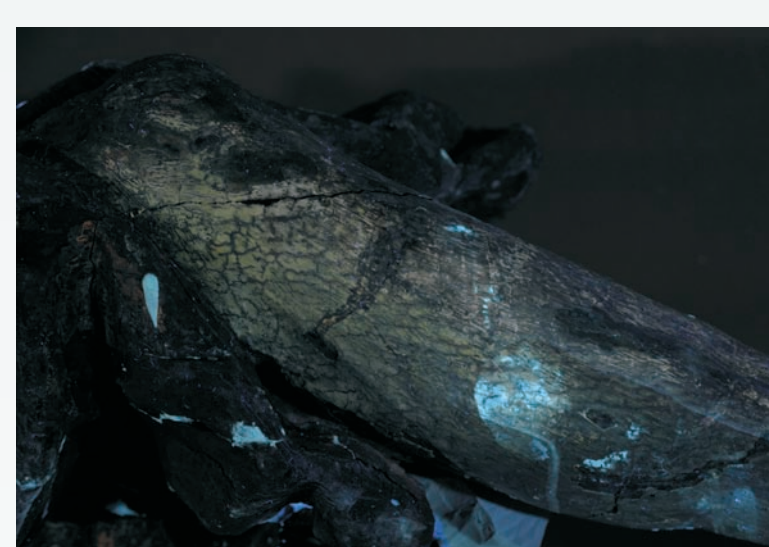
Sl.10. Zatečeno stanje Anđela - detalj desne noge 2011., na UV-fotografiji se primjećuju ostaci konsolidanta i na dijelu desne noge se sumnja na prisutnost mikroorganizama zbog čega je s tog mjesta uzet uzorak za mikrobiološku analizu. (dokumentacija HRZ-a, snimio M. Braun)  
Pic.10. Prior condition of the Angel - right leg detail in 2011; UV photography shows consolidant's debris and there's suspicion for microorganisms, the piece for the further microbiological analyze has taken (documentation of the Croatian Conservation Institute; photo by M. Braun)

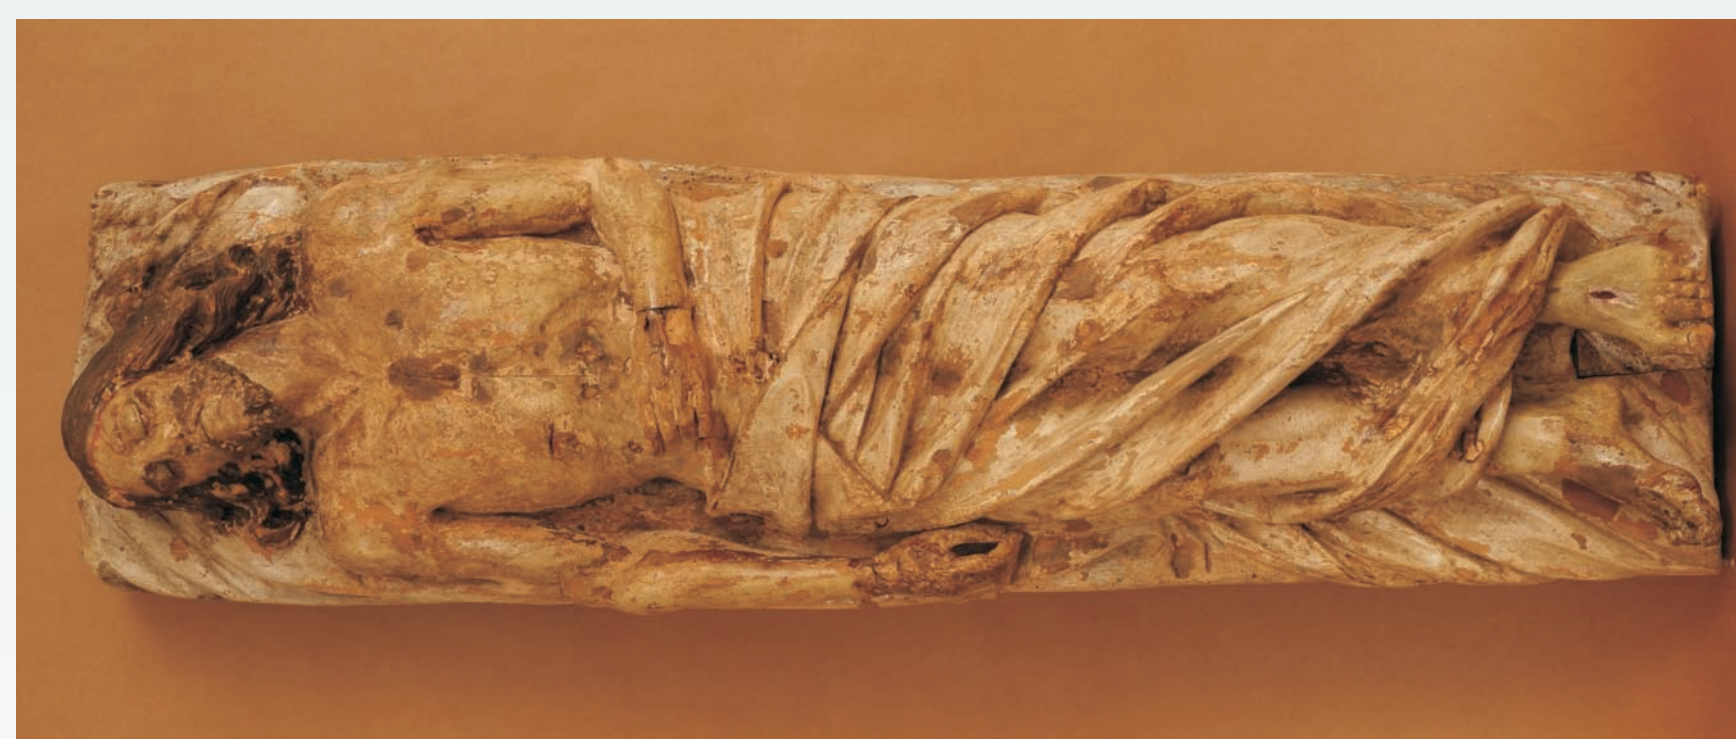
Sl.11. Zatečeno stanje Mrtvog Krista - total, fotografija prikazuje današnje stanje nakon izvođenja konzervatorsko-restauratorskih radova završenih 2006. godine (dokumentacija HRZ-a, snimio M. Braun)  
Pic.11. Prior condition of the Dead Christ - total, the photograph shows present condition after conservation-restoration works finished in 2006. (documentation of the Croatian Conservation Institute; photo by M. Braun)

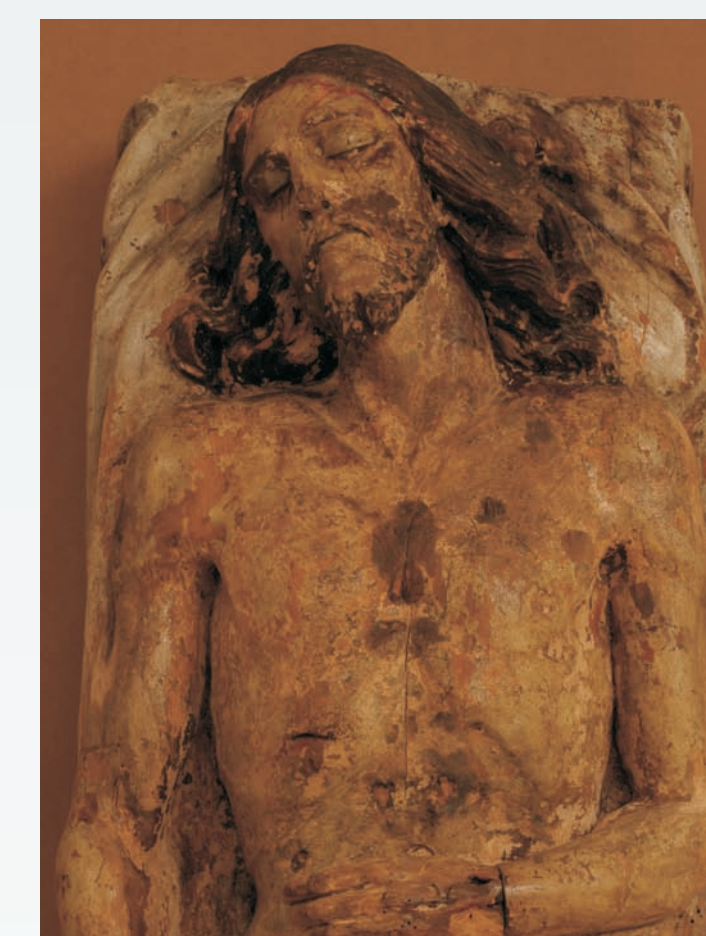
Sl.12. Zatečeno stanje Mrtvog Krista - detalj torza, fotografija prikazuje današnje stanje nakon izvođenja konzervatorsko-restauratorskih radova završenih 2006. godine (dokumentacija HRZ-a, snimio M. Braun)  
Pic.12. Prior condition of the Dead Christ - torso detail; the photograph shows present condition after conservation-restoration works finished in 2006. (Documentation of the Croatian Conservation Institute; photo by M. Braun)

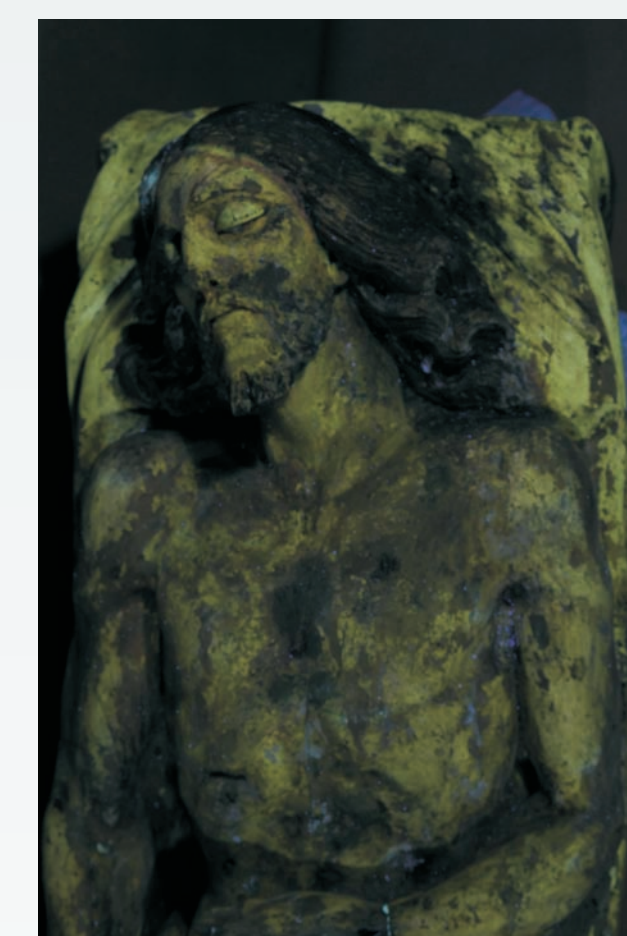
Sl.13. Zatečeno stanje Mrtvog Krista - detalj torza, na UV-fotografiji primjećuju se ostaci konsolidanta i nisu primijećeni mikroorganizmi (dokumentacija HRZ-a, snimio M. Braun)  
Pic.13. Prior condition of the Dead Christ - torso detail; UV photography shows consolidant's debris and there's no sign of microorganisms (documentation of the Croatian Conservation Institute; photo by M. Braun)
