POVIJEST PERISTILA: SJEVERNI DIO ISTOČNE KOLONADE

THE HISTORY OF THE PERISTYLE: NORTHERN PART OF THE EASTERN COLONNADE

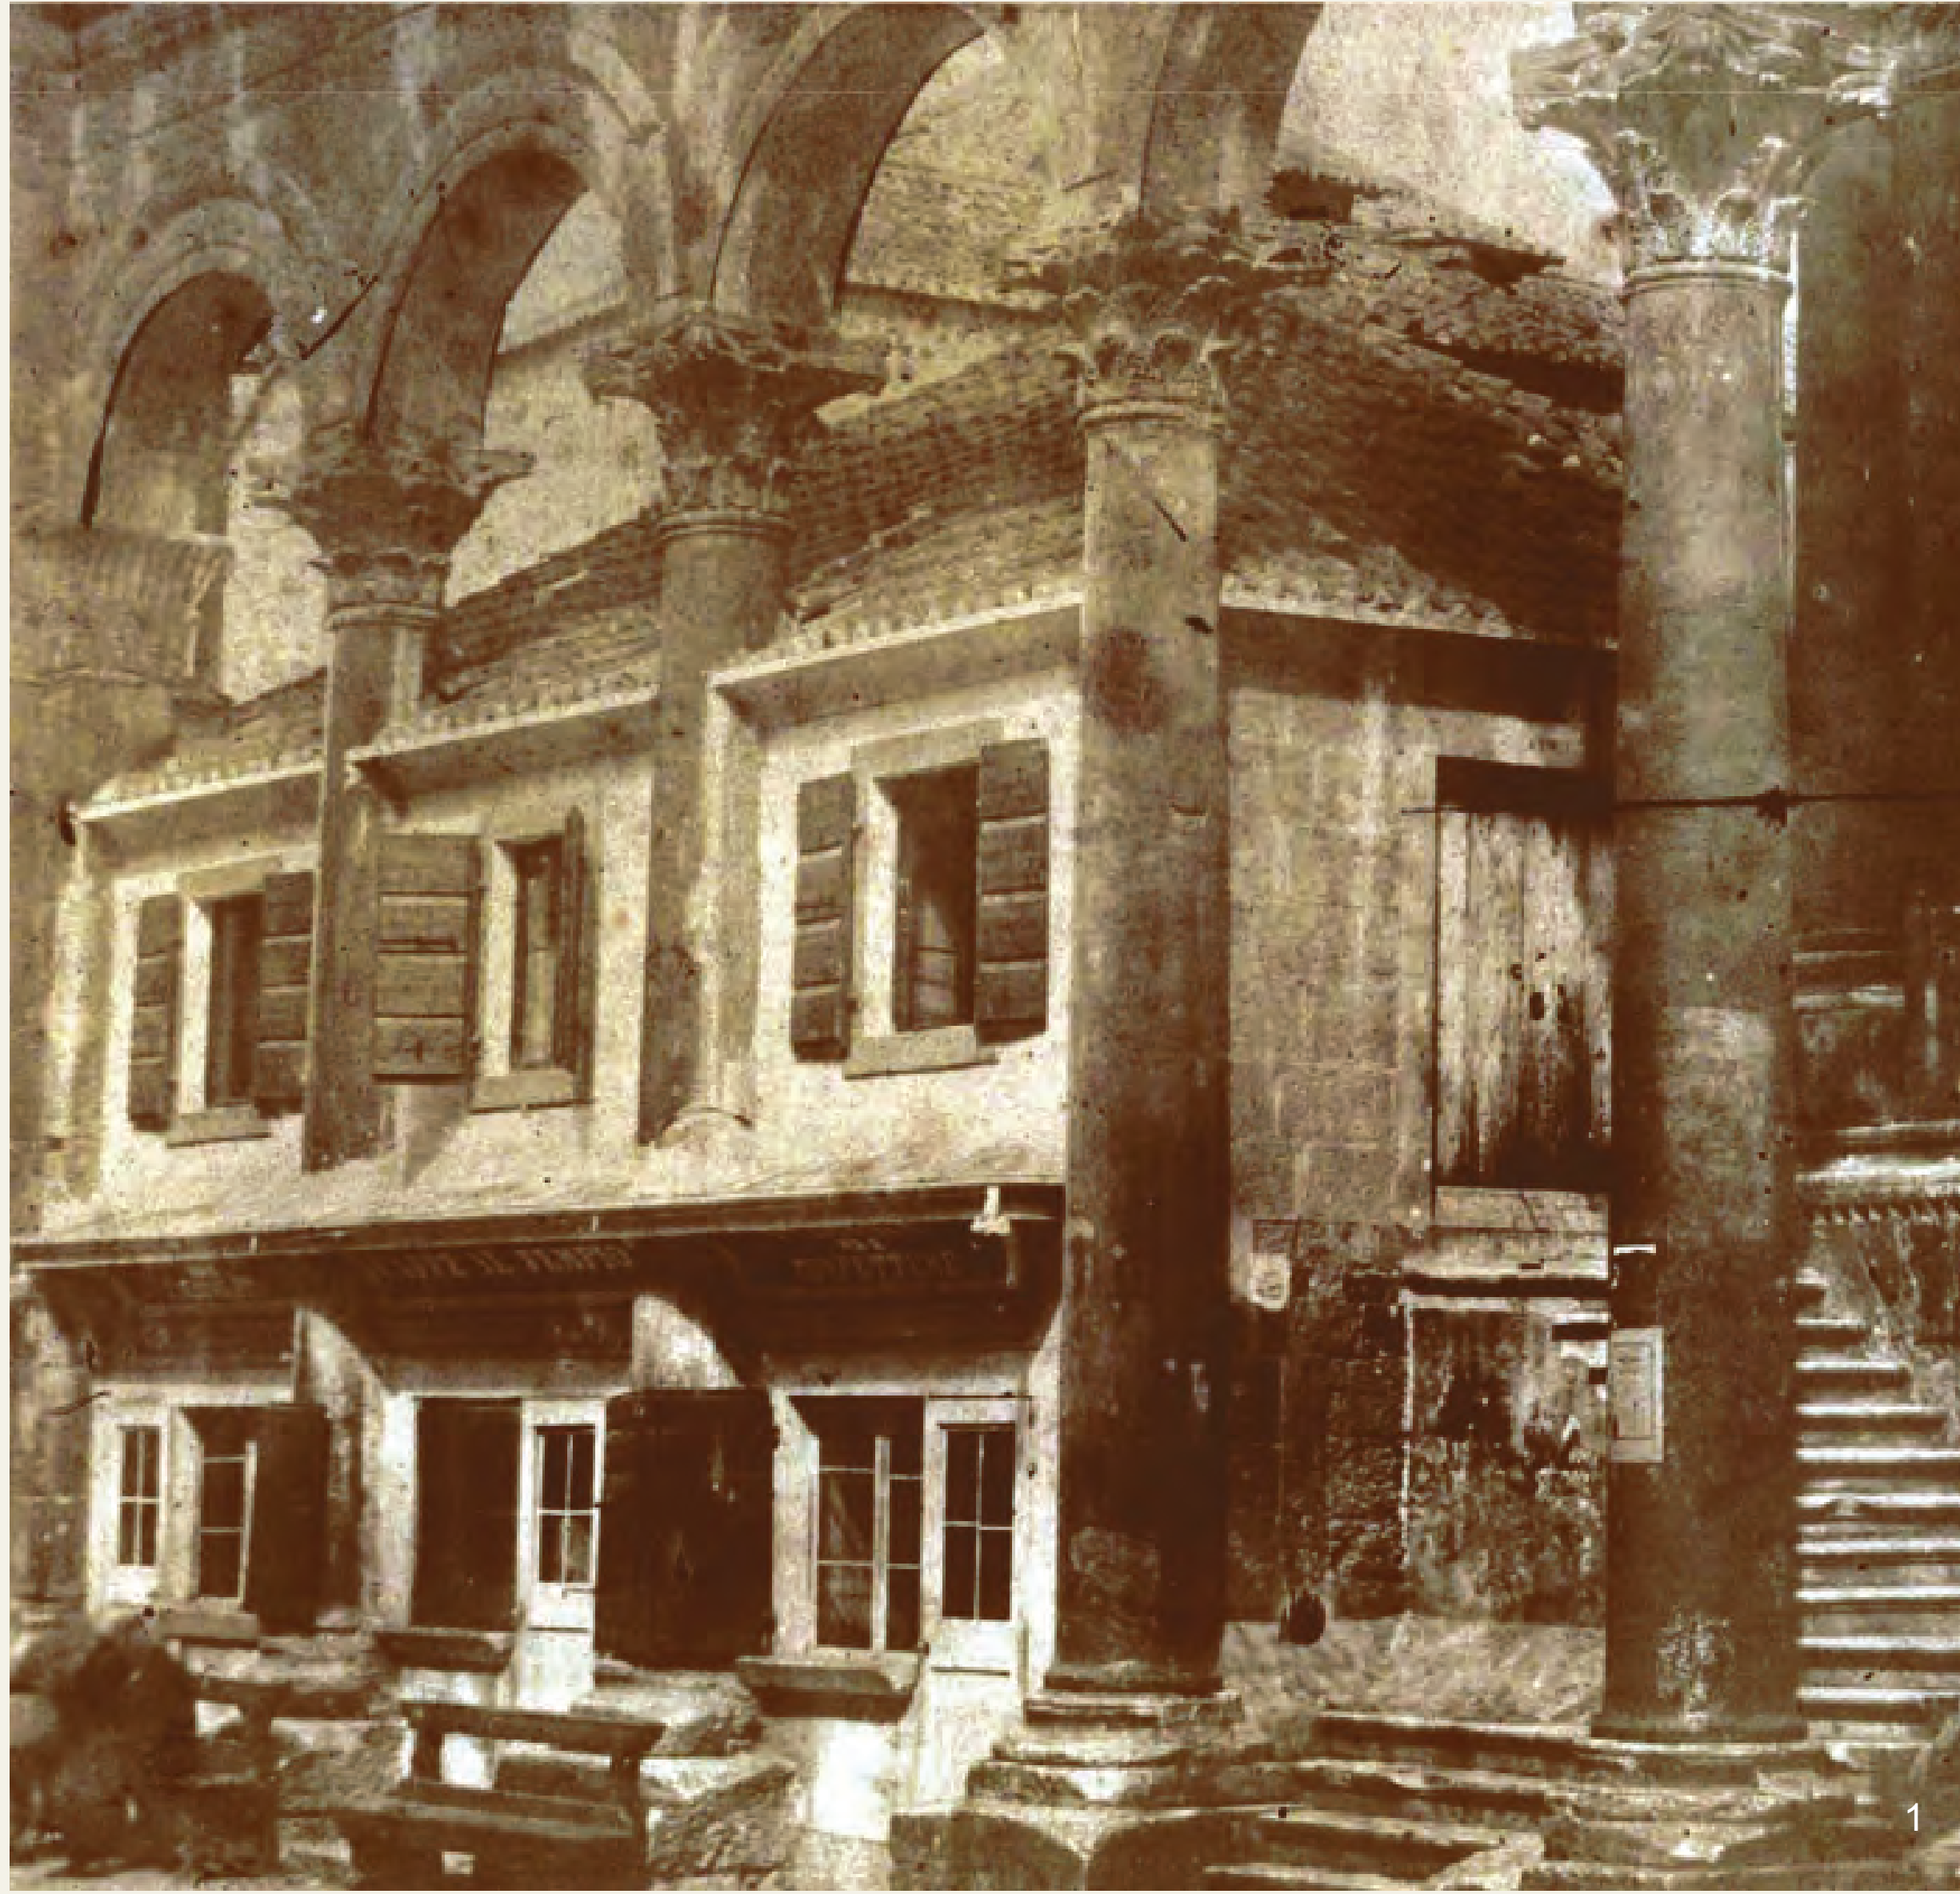
Sl. 1 Kavana 'Al Tempio' unutar sjevernog dijela istočne kolonade Peristila, prije 1876. godine.

Fig. 1 The Al Tempio Café inside the northern part of the eastern colonnade of the Peristyle, before 1876

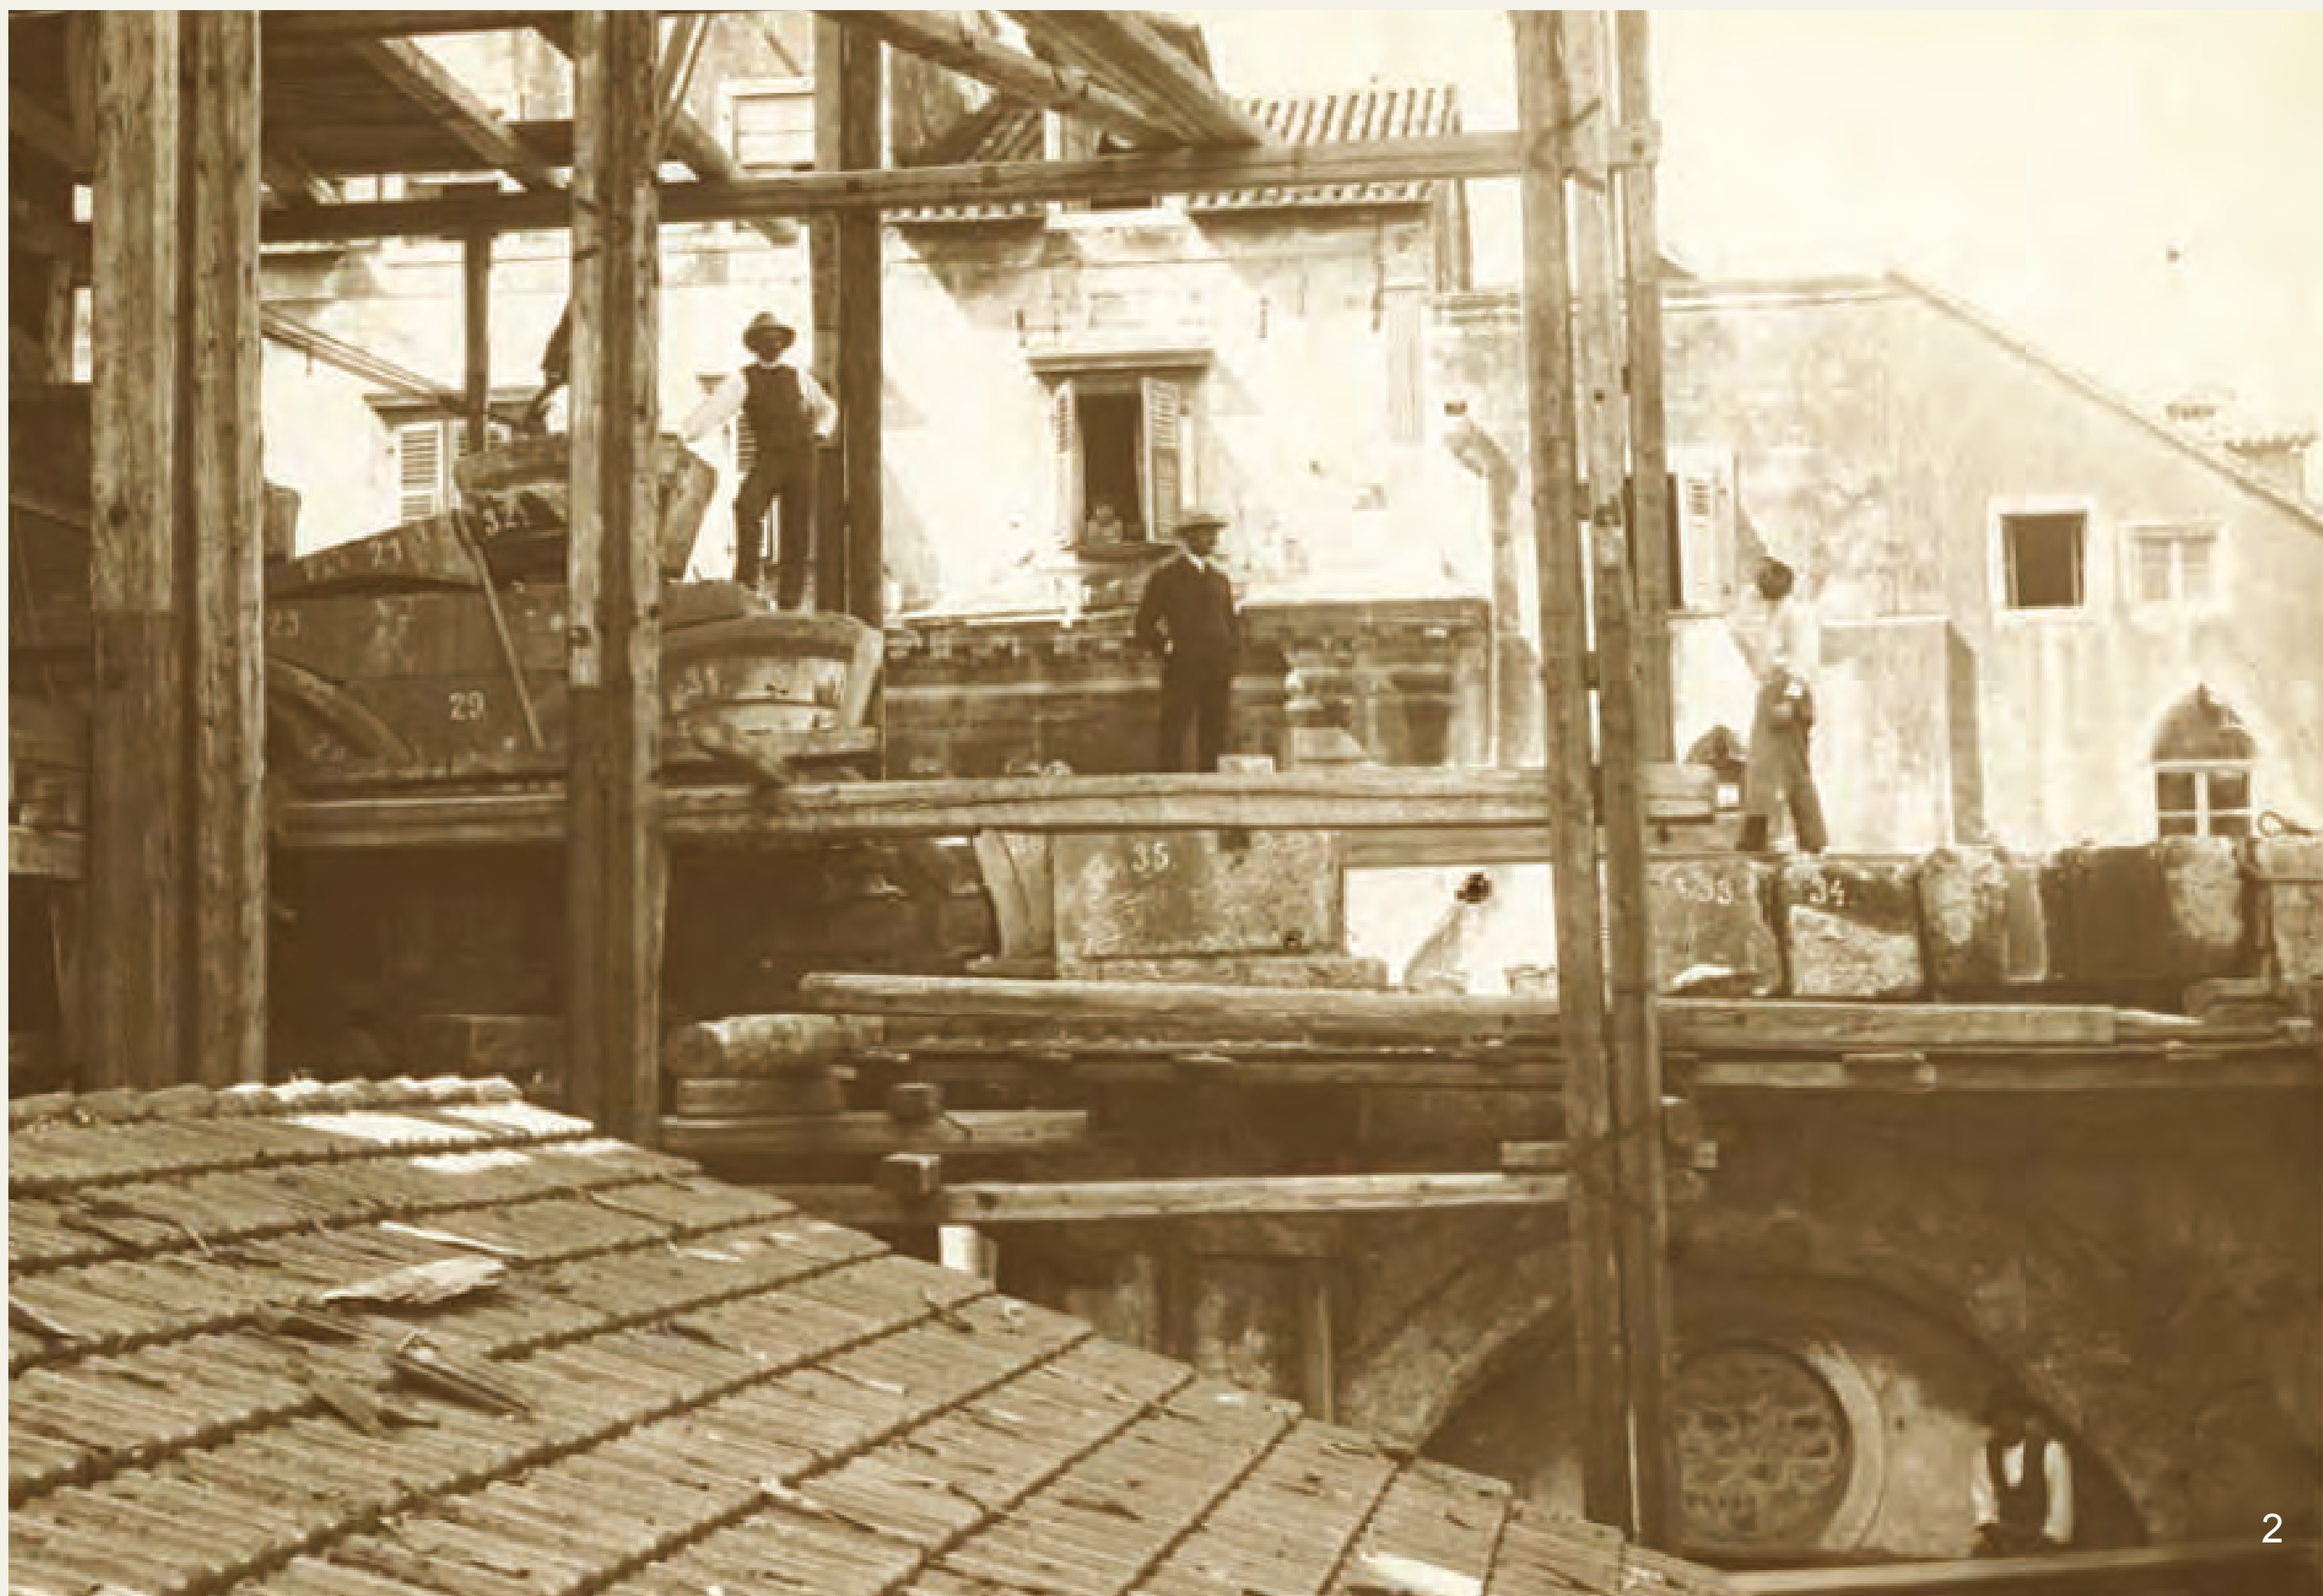
Sl. 2 Sjeverni dio istočne kolonade Peristila 1907. godine, demontaža gornjeg dijela kolonade.

Fig. 2 The northern part of the eastern colonnade of the Peristyle in 1907, disassembly of the upper part of the colonnade

The works on the reconstruction of the colonnade were conferred to the engineer Antonio Inchiostro, and they were executed under the supervision of Alois Hauser, who was also the chief conservator in charge of the cathedral reconstruction. Some of the damage to the eastern colonnade of the Peristyle remaining after the demolition of the Al Tempio Café was repaired at the time of the operation itself; however the profound rehabilitation was undertaken only in 1907. Besides the reconstruction of two heavily damaged north columns, the cornice and the trabeation of the part of the east colonnade were removed and mounted again. The works were executed under the supervision of the Diocletian's Palace Commission, established by the initiative and efforts of chief conservator, rev. Frane Bulić.

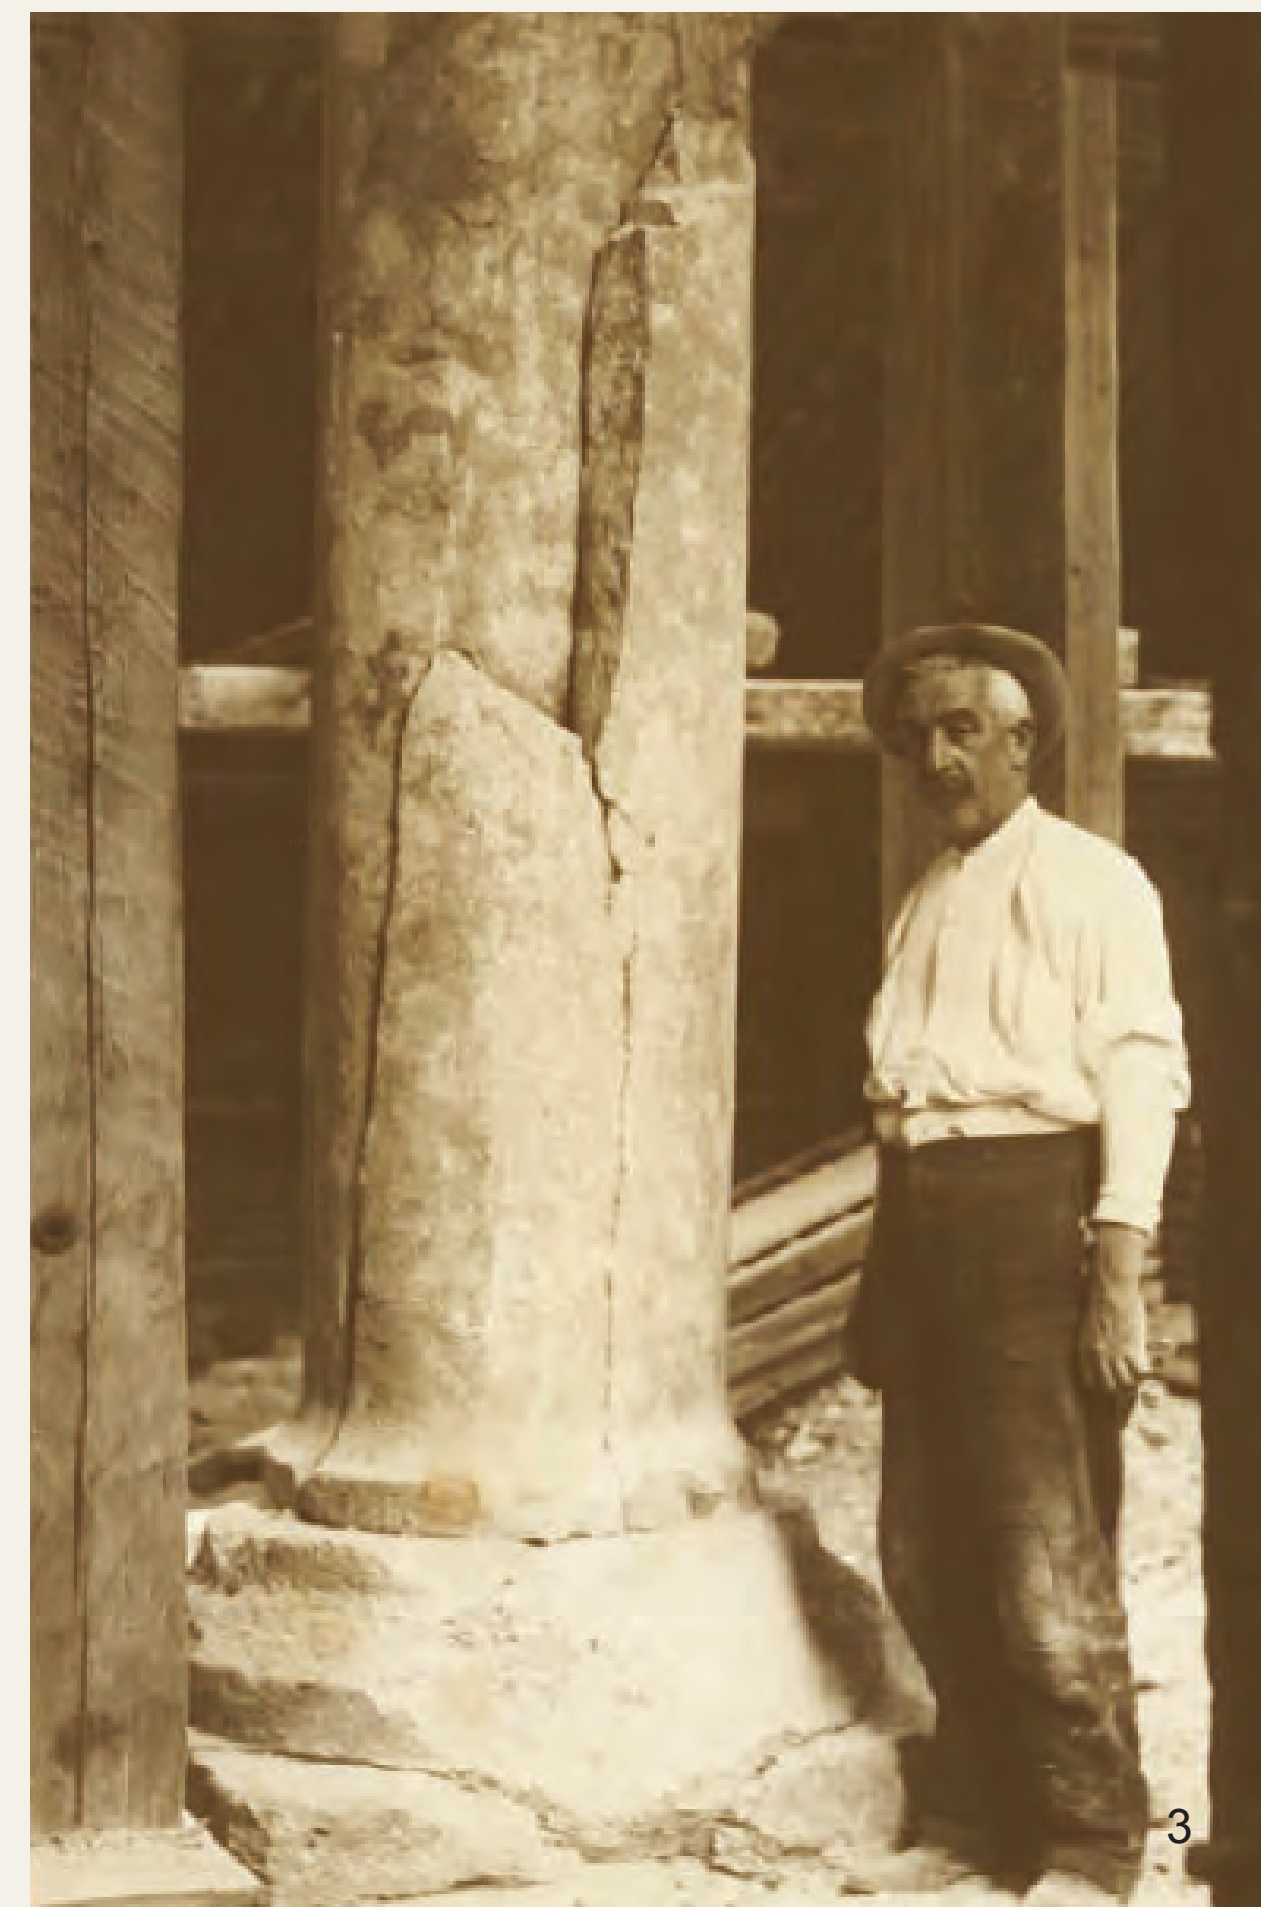
Sl. 3 Sjeverni dio istočne kolonade Peristila 1907. godine, restauracija drugog stupa.

Fig. 3 The northern part of the eastern colonnade of the Peristyle in 1907, the restoration of the second column
