# KONZERVATORSKO-RESTAURATORSKI RADOVI U PRIZEMLJU

## CONSERVATION-RESTORATION WORKS ON THE GROUND FLOOR

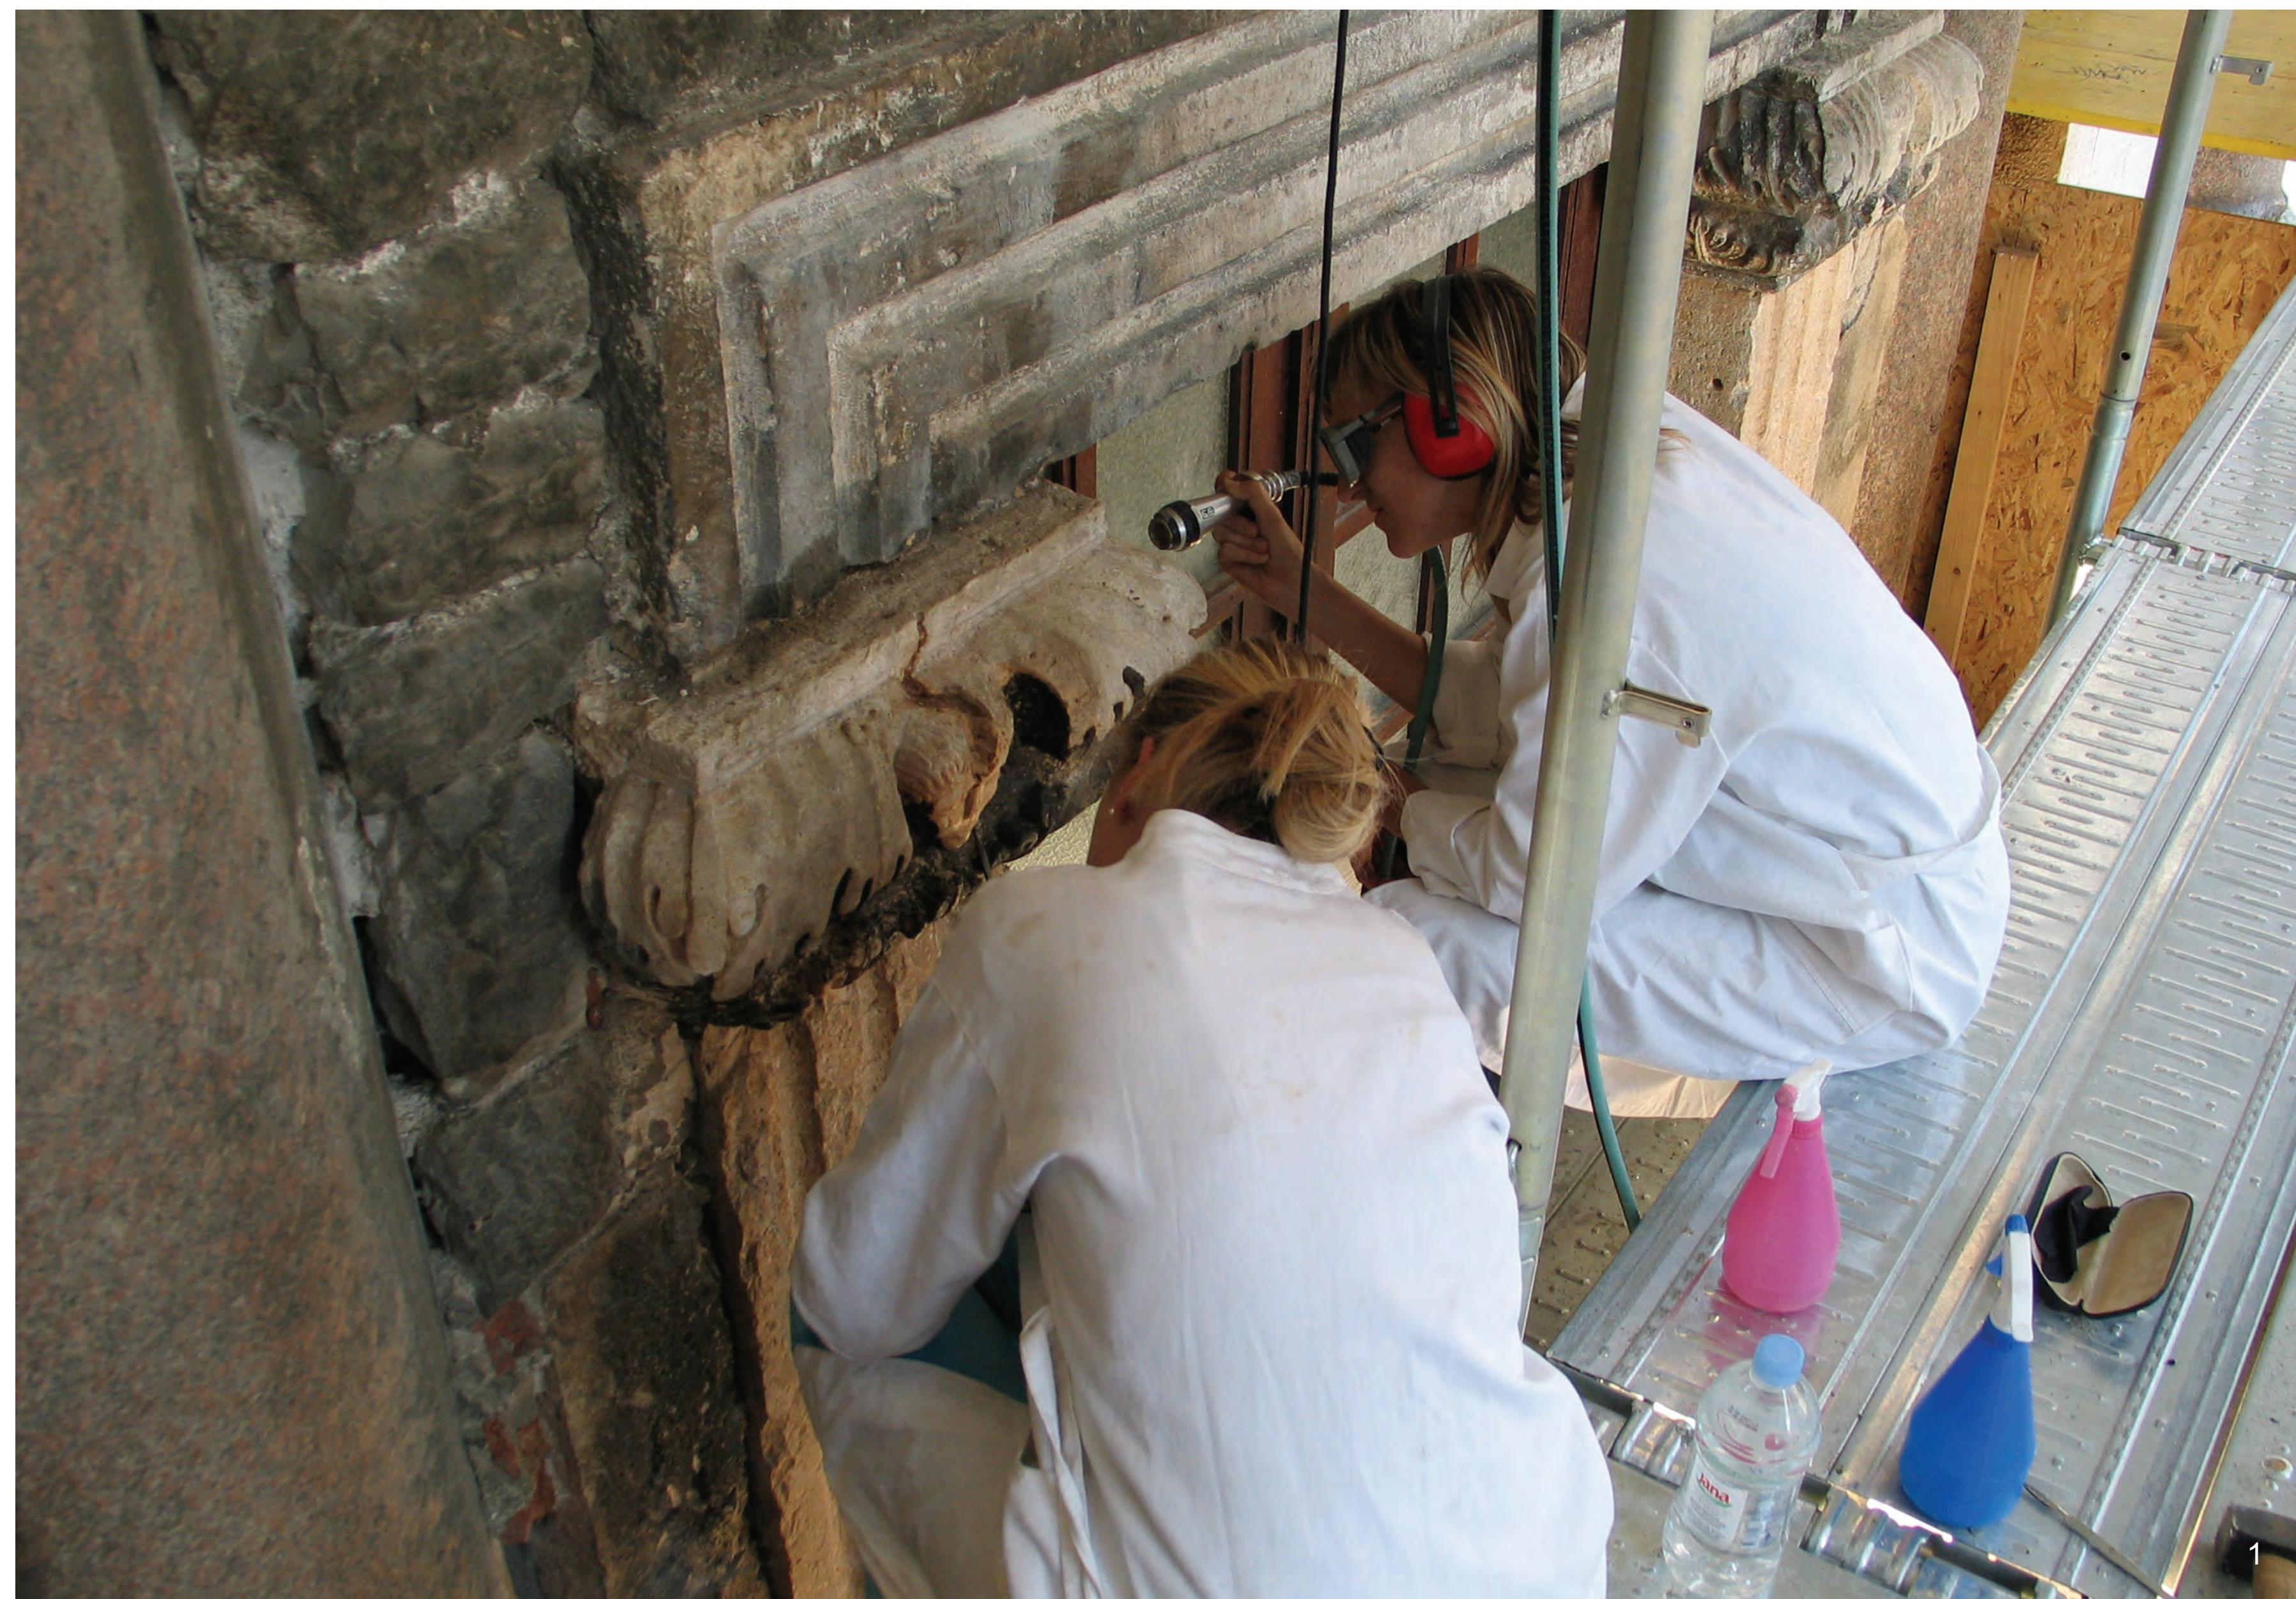
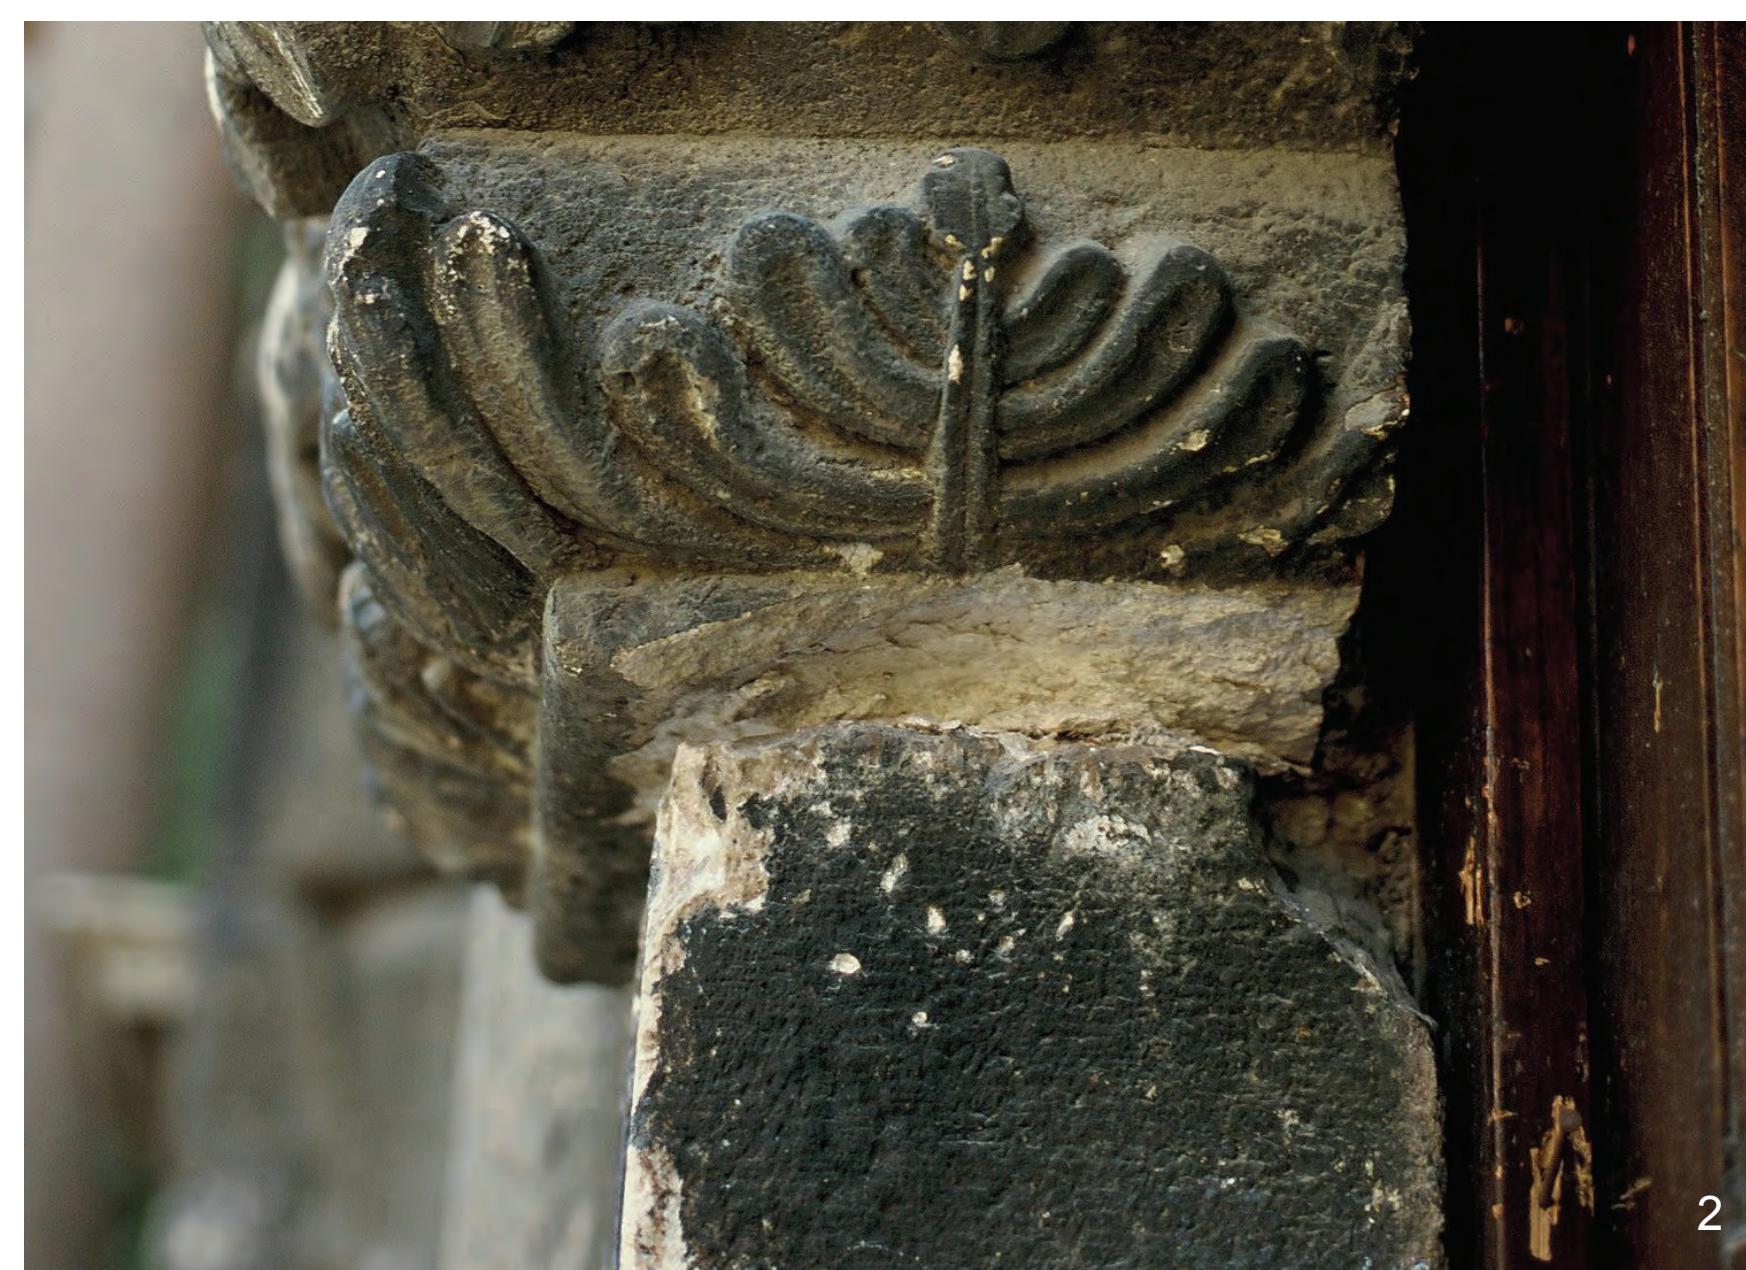
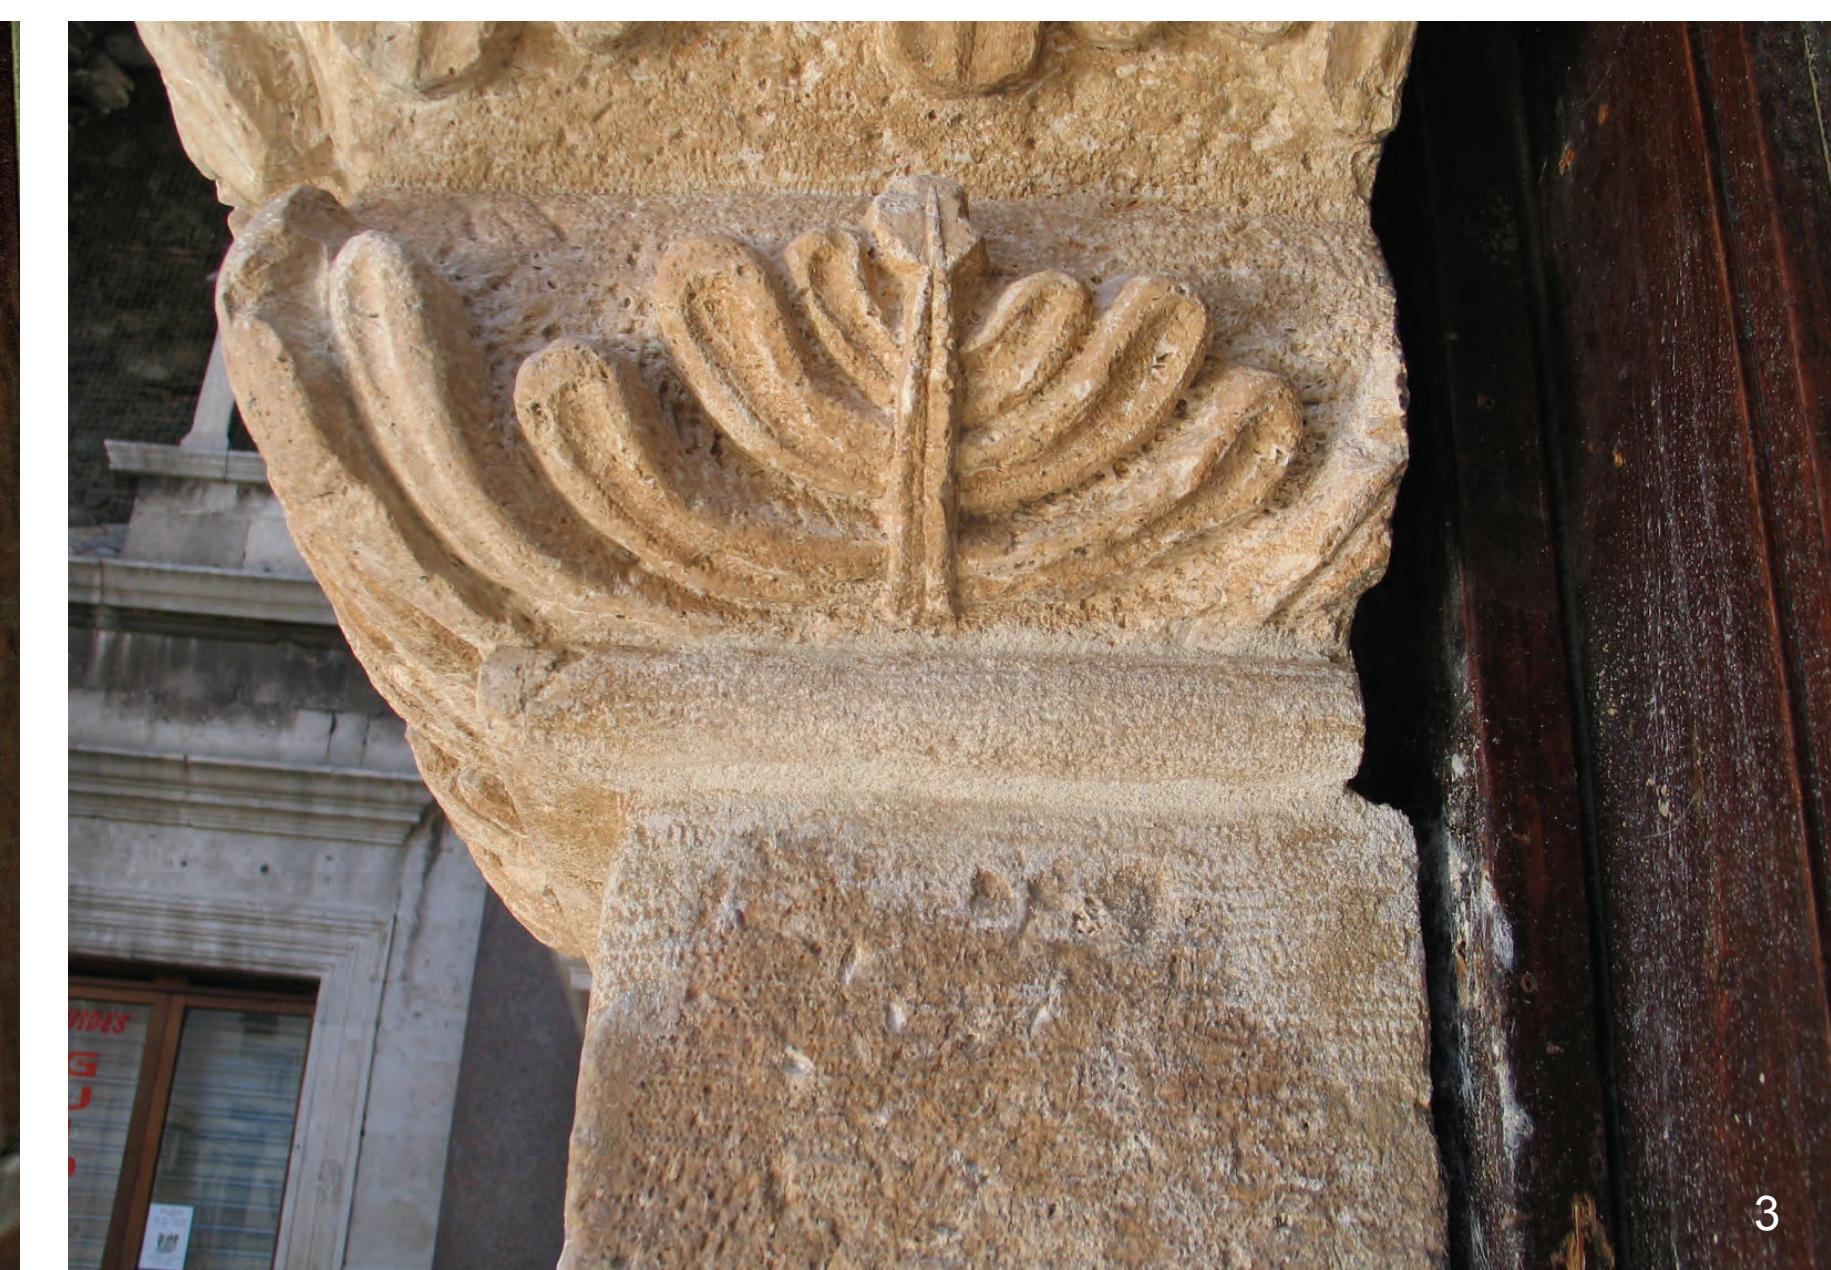
Nakon čišćenja je osobito zabilješnuo monumentalni portal na desnoj strani pročelja (Sl. 1-3).

Velike šupljine na licima kamenih blokova pilona zapunjene su umjetnim kamenom kako bi se spriječio prodor vode u strukturu kamena.

All the operations previously described were also carried out on the ground floor of the palace: the removal of organic and inorganic dirt from the stone frames of the doors and windows and parts of the ancient colonnade, removal of cement joints and patches on the bases of the columns and replacing them with new joints of acrylic-lime mortar, consolidating the cracks, reconstruction operations in artificial stone. After cleaning, the monumental portal on the right side of the façade particularly shone out (Fig. 1-3). Large voids on the faces of the ashlar of the pylon were filled with artificial stone to prevent the seepage of water into the structure of the tone.

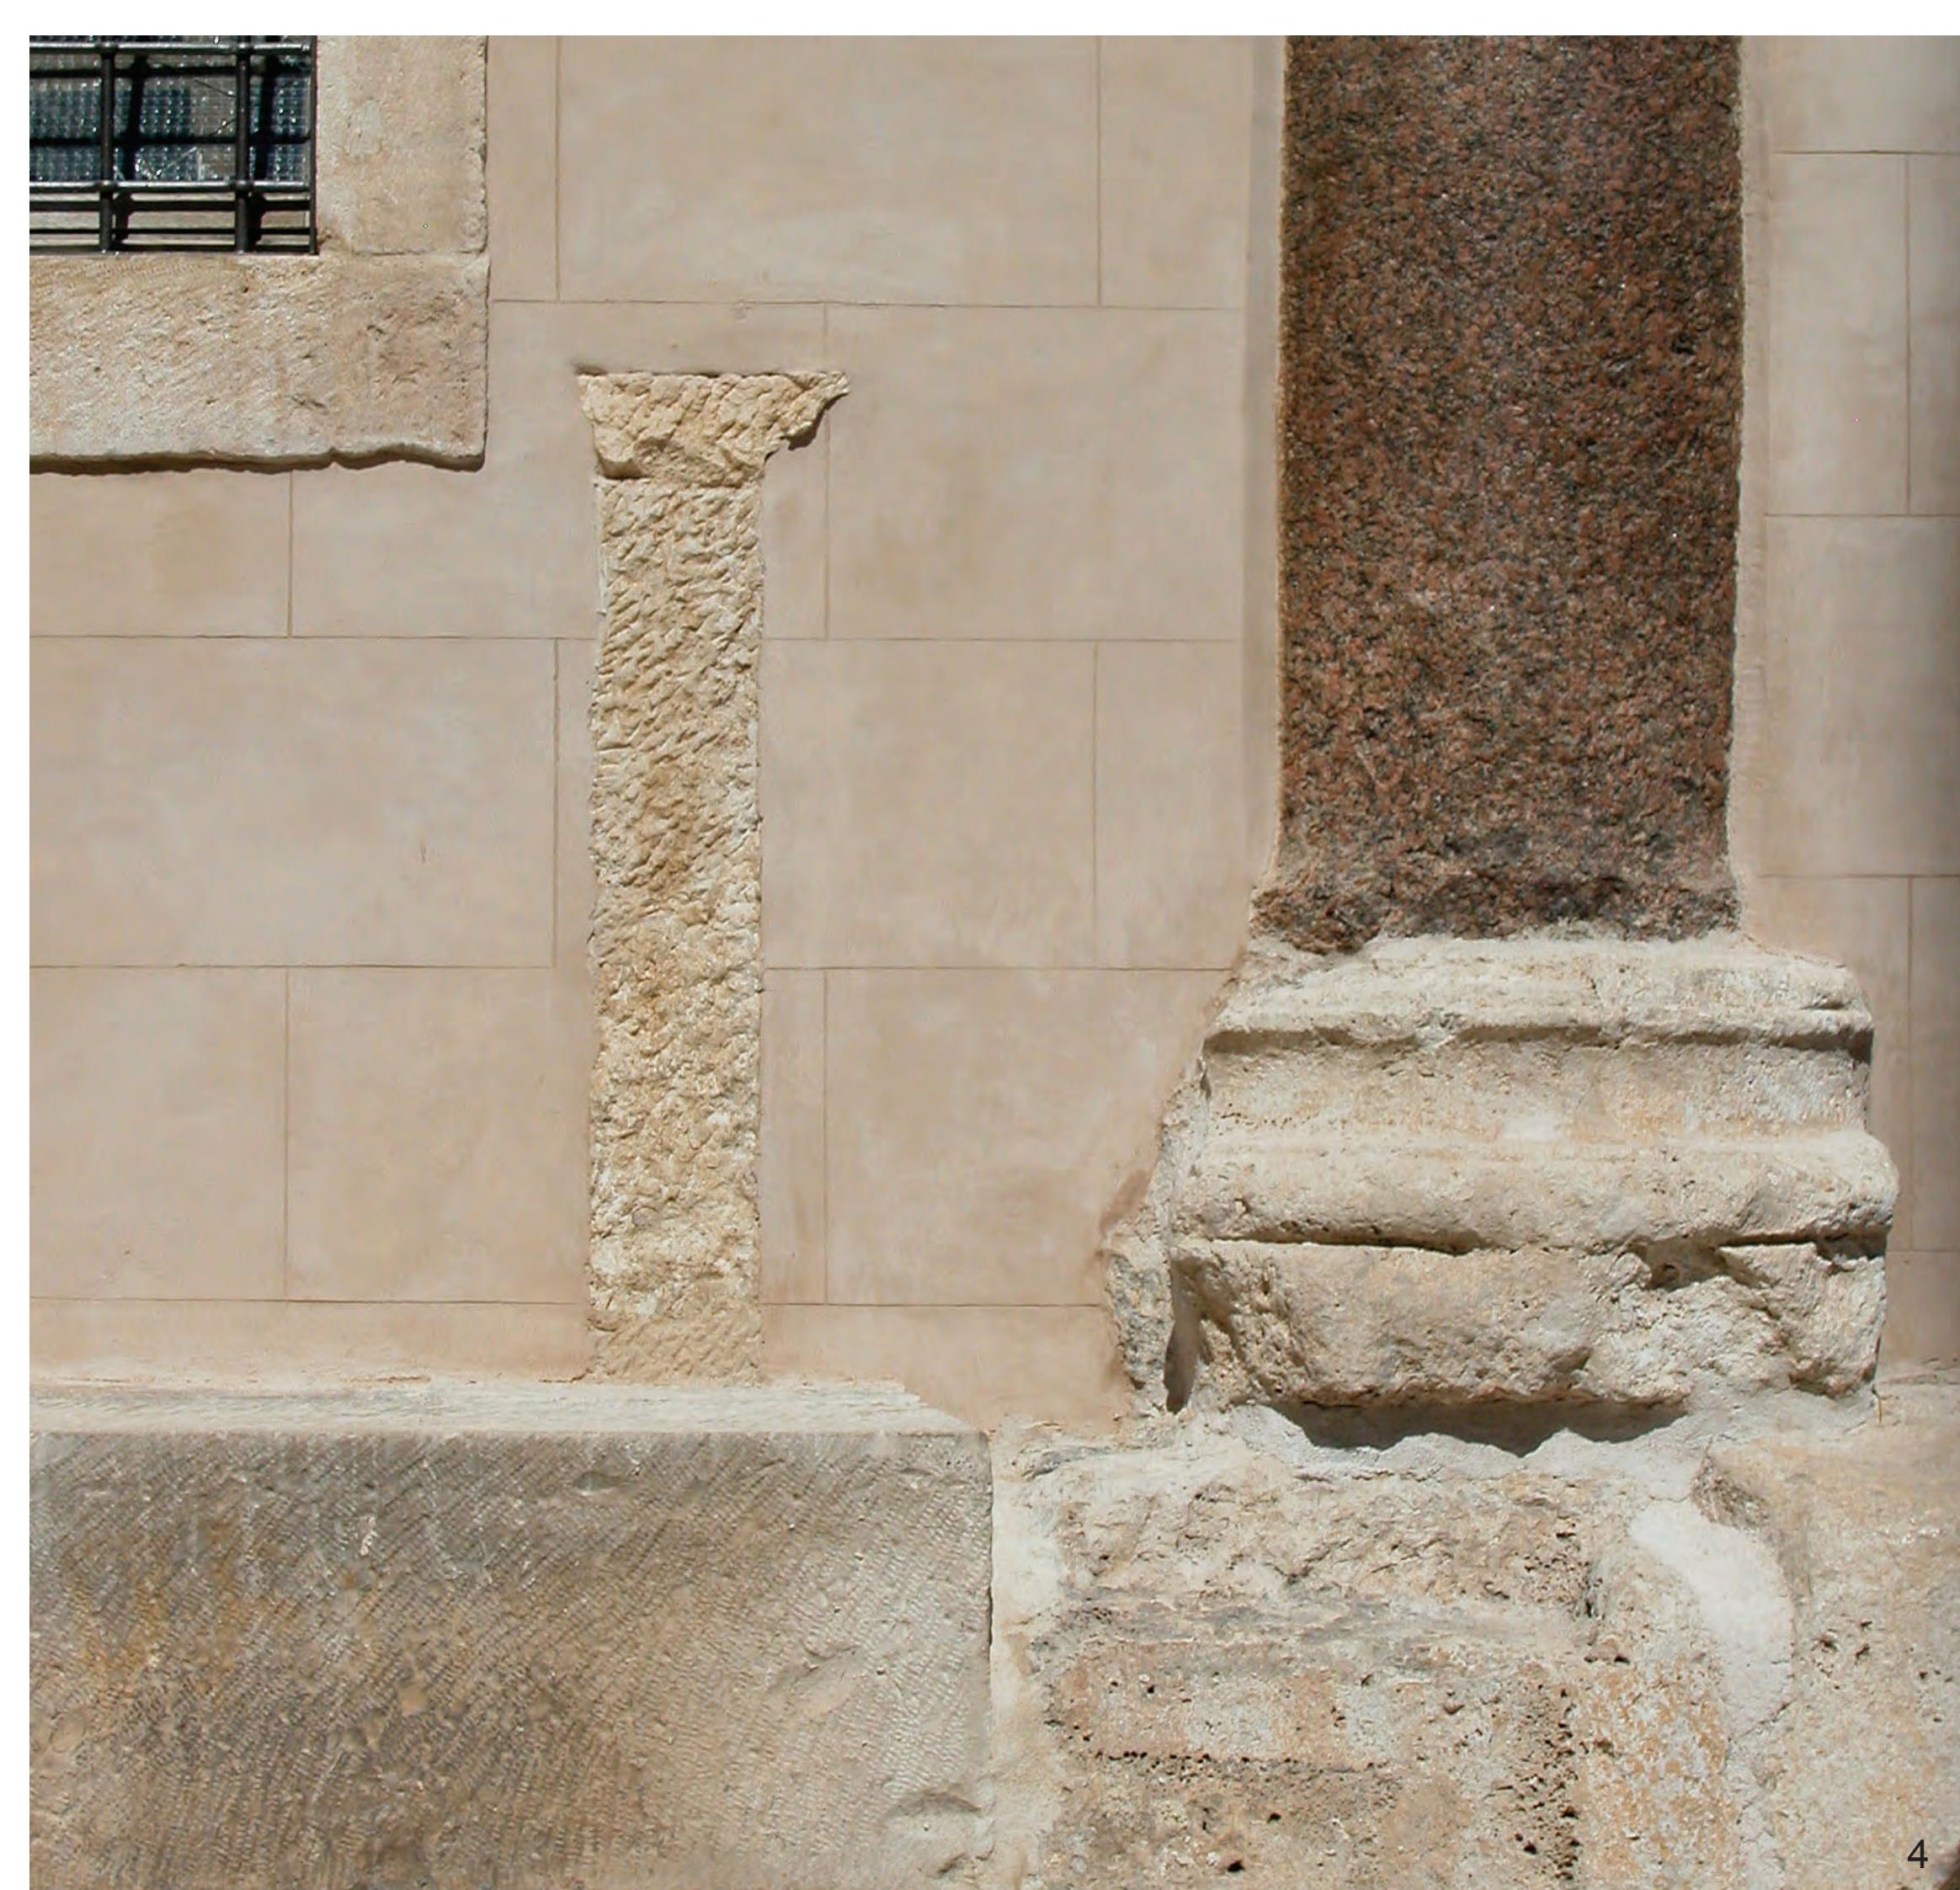
Pronađeni ostaci kamene ograde su očišćeni od naslaga morta i nečistoća (Sl. 4).

The remains of the stone balustrade were cleaned of their layers of mortar and dirt (Fig. 4). The missing parts were replaced with artificial stone, and the reconstruction of the plaster in the ground floor was done in such a way as to have the preserved fragments still visible.

Nedostajući dijelovi su nadomješteni umjetnim kamenom, a rekonstrukcija žbuke u prizemlju izvedena tako da sačuvani fragment ostane i dalje vidljiv.
