HRVATSKI  
RESTAURATORSKI  
ZAVOD

# PREGLJED TRENUTNOG STANJA DRVENIH POLIKROMIRANIH SKULPTURA IZ GORE

## OVERVIEW OF THE CURRENT STATE OF WOODEN POLYCHROMED SCULPTURES FROM GORA

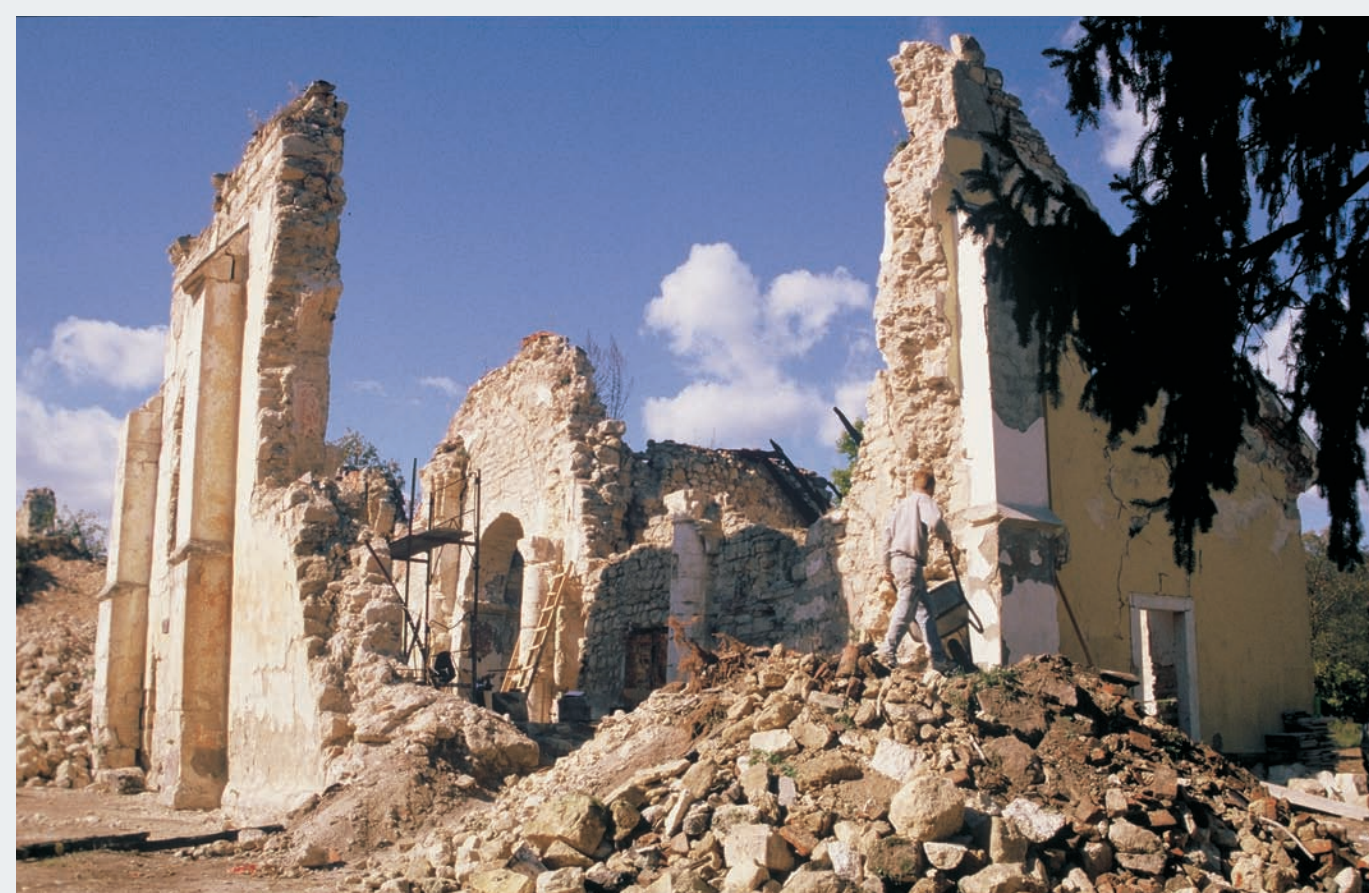
Sl.1. Srušena crkva Blažene Djevice Marije u Gori kraj Petrinje  
Pic.1. Ruins of the Blessed Virgin Mary church in Gora near Petrinja
